## SECTION 22 - PLANNING ASSISTANCE TO STATES PROGRAM

# Pamet River Investigation Truro, Massachusetts

November 2019

US Army Corps  
Of Engineers  
New England District

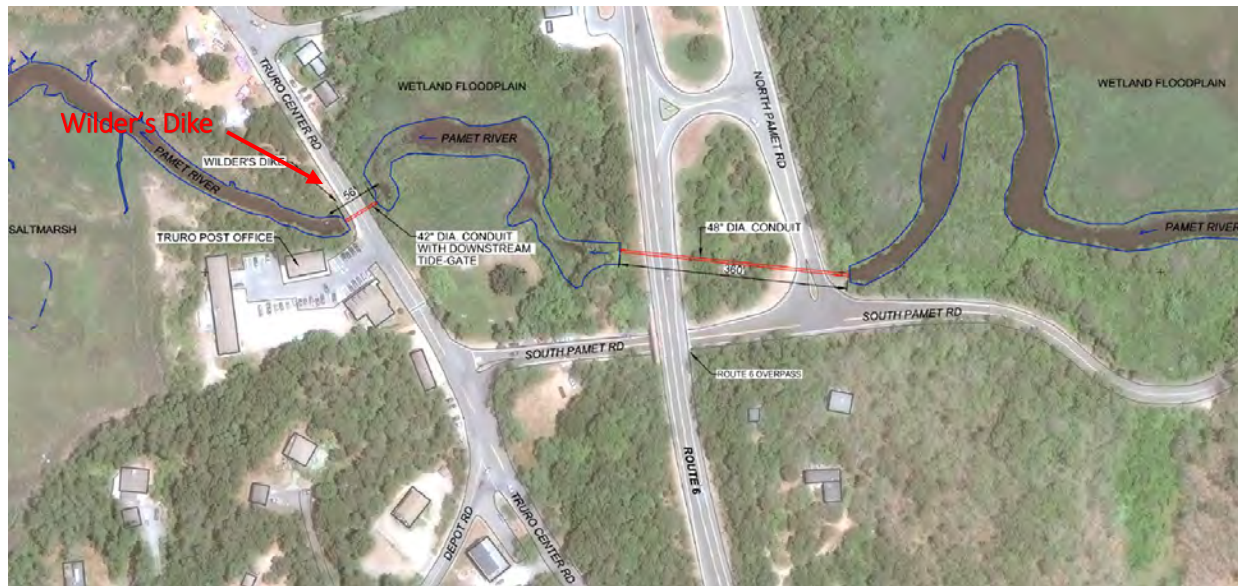
Figure 3: Location Map - Pamet River - Conveyance Design Focus Area

The Pamet River consists of two hydrologically different reaches separated by Wilder's Dike, just west of Route 6. Currently, the upper Pamet east of Wilders Dike is a freshwater system, and the lower Pamet west of Wilders Dike is saltwater. The dike was constructed in 1869, but the tide gate and Route 6 embankment was constructed in the mid-1950s. The two constrictions, and focus areas of this design effort, that hinder conveyance between the fresh and saltwater systems are a 56-foot long, 3.5-foot diameter culvert with tide gate through Wilder's Dike, and a 360-foot long, 4.0-foot diameter culvert through the Route 6 embankment and North Pamet Road (Figure 3). The dike's tidal flap gate seals off the tidal influence upstream of the dike approximately 2 hours before high tide, essentially preventing saltwater intrusion east of the dike to the upper Pamet. The river's freshwater system is fed by groundwater and surface runoff.

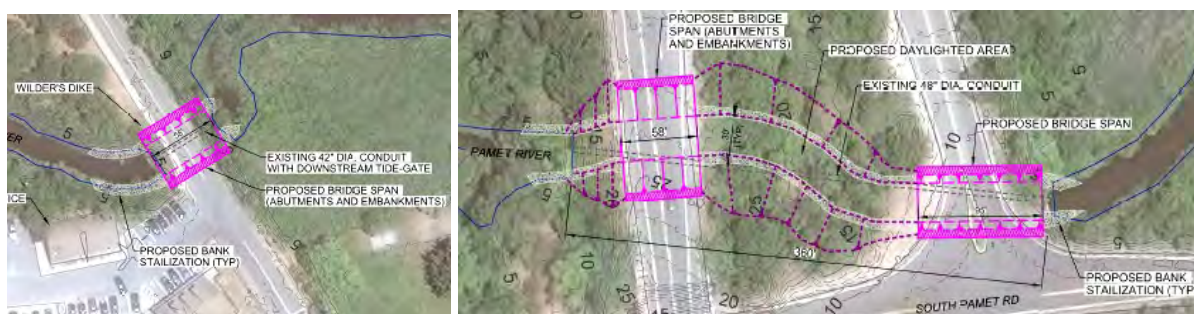
Figure 7: Alternative #4

### 3.3.4 Alternative #4: Open Bridge Span

See sheet A-104 of the attached drawings

Under Alternatives #3 and #4 scenarios, the removal of the tide gate and larger river conveyance will correlate to higher river stages upstream of Wilder's Dike as the high tides migrate approximately ½-mile beyond the dike. These results reflect a change in water table elevation (groundwater rise) of about 0.5 feet compared to Alternative #1 (existing conditions) or Alternative #2 (with a tide gate at Wilder's Dike).

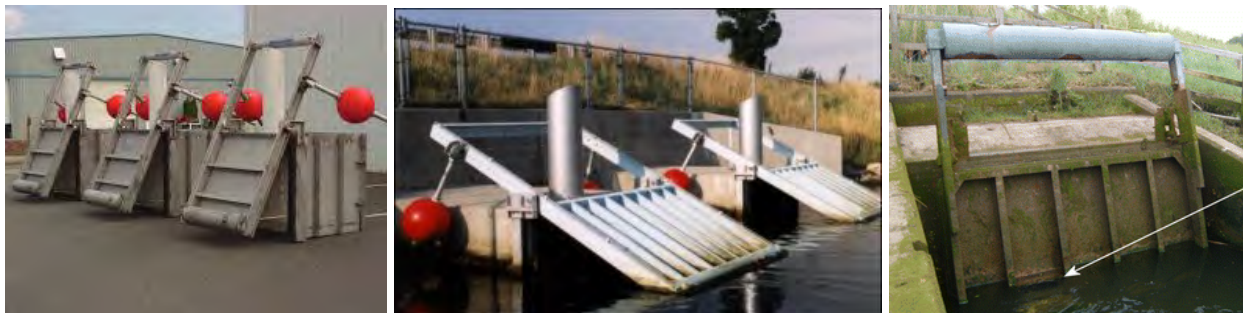
Figure 9: Self-Regulating Tide Gate

**4.3 Self-Regulating Tide (SRT) Gate:** A variety of tidal gate systems exist, ranging from simple flap gates to computer/electronically operated sluice gates. For the sake of this project, a Self-Regulating Tide (SRT) Gate was selected. Most SRT gates have two separate floats that serve different functions. The lower float is intended to keep the gate as open as possible by resting on top of the water surface, promoting maximum flow. Once water level rises above a certain elevation (customized for each SRT gate), the upper floats are engaged which begin to close the gate and seal it off at/above a certain water level. This system promotes better flow and more control over when the gate fully closes, compared to simple flap gates. If this system is carried forward into a design effort, the decision to use one large gate, or 2-3 smaller gates will need to be investigated.

The analysis showed that Alternative #2, consisting of a 16 feet wide x 4 feet tall culvert with a self-regulating tide gate, would be the most effective at reducing both the river stages and duration of time to drain salt water that had entered the upper portion of the Pamet River during an overwash event. In a scenario where Ballston Beach is overtopped, (such as the event of March 2018), a comparison between existing conditions (Alternative #1-“No Action”) and the three alternatives, consisting of larger culverts, both with and without a tide gate, found that Alternative #2 was the most effective alternative in decreasing overtopping drainage times. The drainage efficiency of Alternative #2 is attributed to a combination of larger culvert capacity (i.e. river conveyance) combined with a tide gate to prevent salt water from passing additional flow volume into the upper Pamet during high tides and storm events that would also need to drain. See Chapter 7 of this report for detailed information on the HEC-RAS evaluation conducted as part of this study.

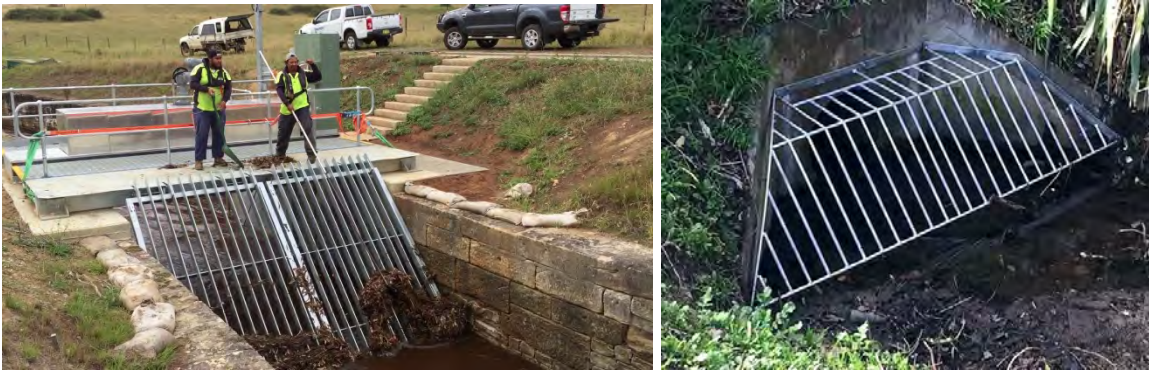
**4.5 Trash-Racks:** Debris has been known to occasionally obstruct the existing conduits. Trash-racks would prevent larger natural and man-made debris from becoming lodged within the box culverts and compromising the systems operations. One consideration for employing trash racks is the need to continuously maintain (check and clear of debris) to prevent debris build-up.

**Figure 10: Trash-Rack Examples**

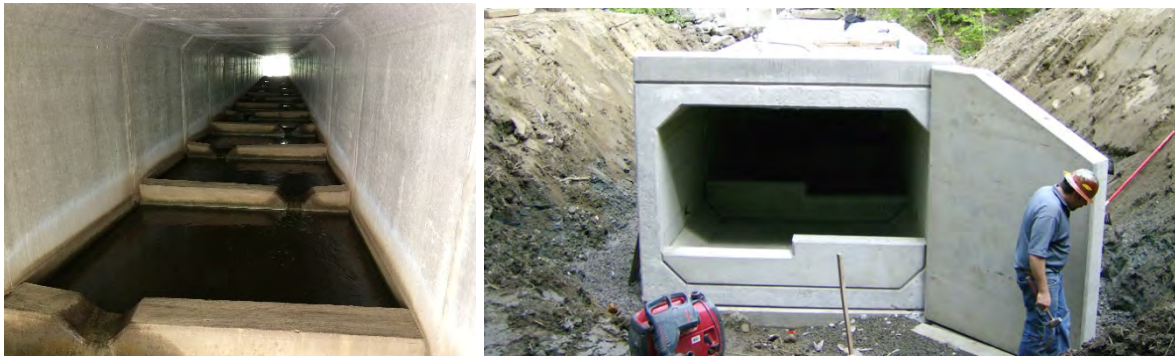
**Figure 11: Box Culvert Weir Examples**

**4.9 Weir Structures:** While not anticipated, should the improved conveyance create water velocity or level issues in the Pamet River, weir structures could be constructed in the box culverts or within the channel itself to better regulate the system as a whole.

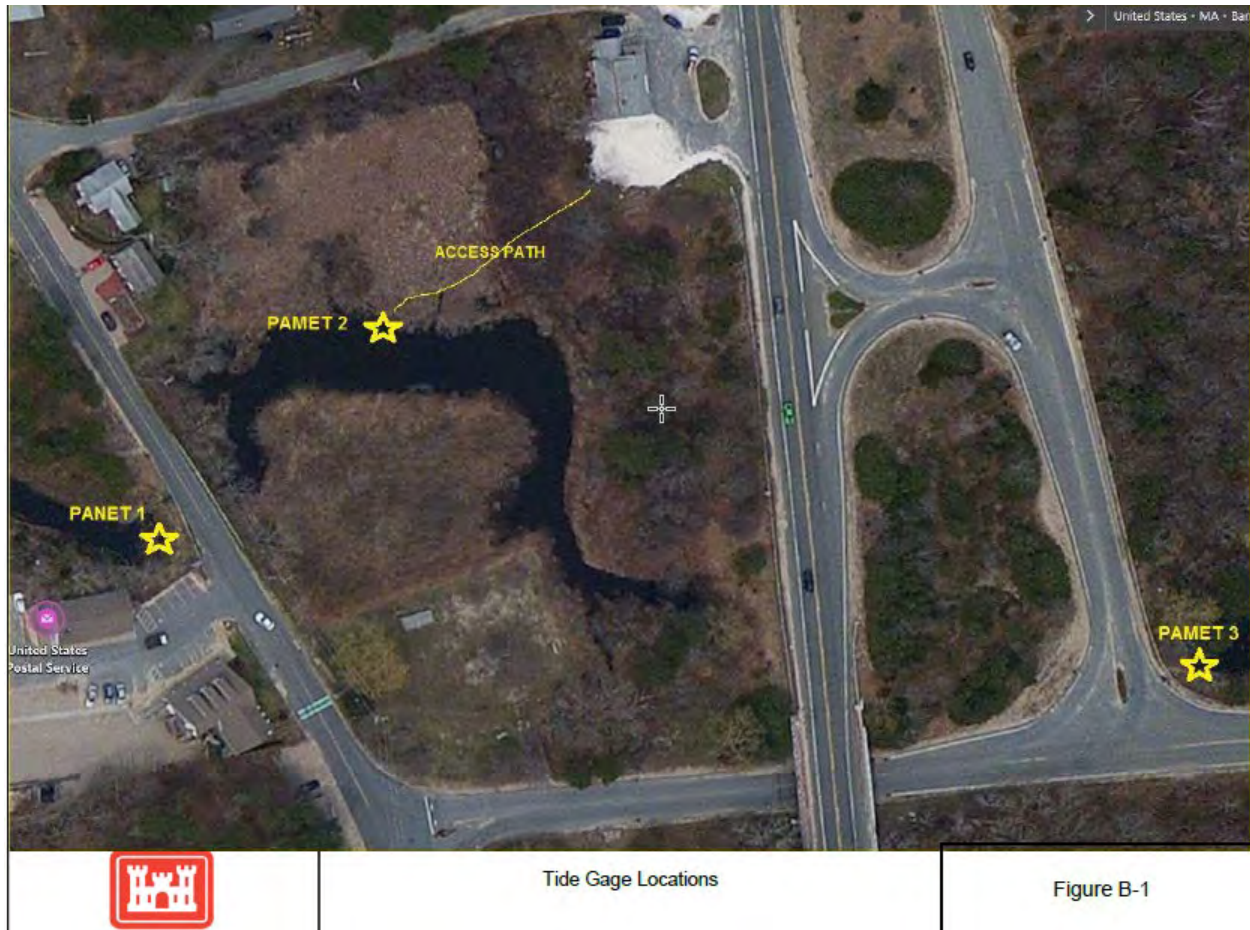
Location Map: Tide Monitoring Stations (Attachment B: Figure B-1)

Beginning in December 2016, three river / tide monitoring stations were deployed in the Pamet River. The stations were named Pamet 1 (Wilder's Dike adjacent to the Post Office downstream of tide gate), Pamet 2 (located upstream of the tide gate in the phragmites marsh between Truro Center Road and Route 6, and midstream between Pamet 1 and 3), and Pamet 3 (located on the upstream concrete wall inlet to the smaller culvert at the North Pamet Road on-ramp to Rt 6). The locations of the three tide gages are shown on See Figures B-1 to B-4 (Attachment B) for Station Locations.

The stations were automated with Sutron X-link data loggers with cellular modems and river stage sensors that measured water level as pressure set to monitor every 15 minutes.

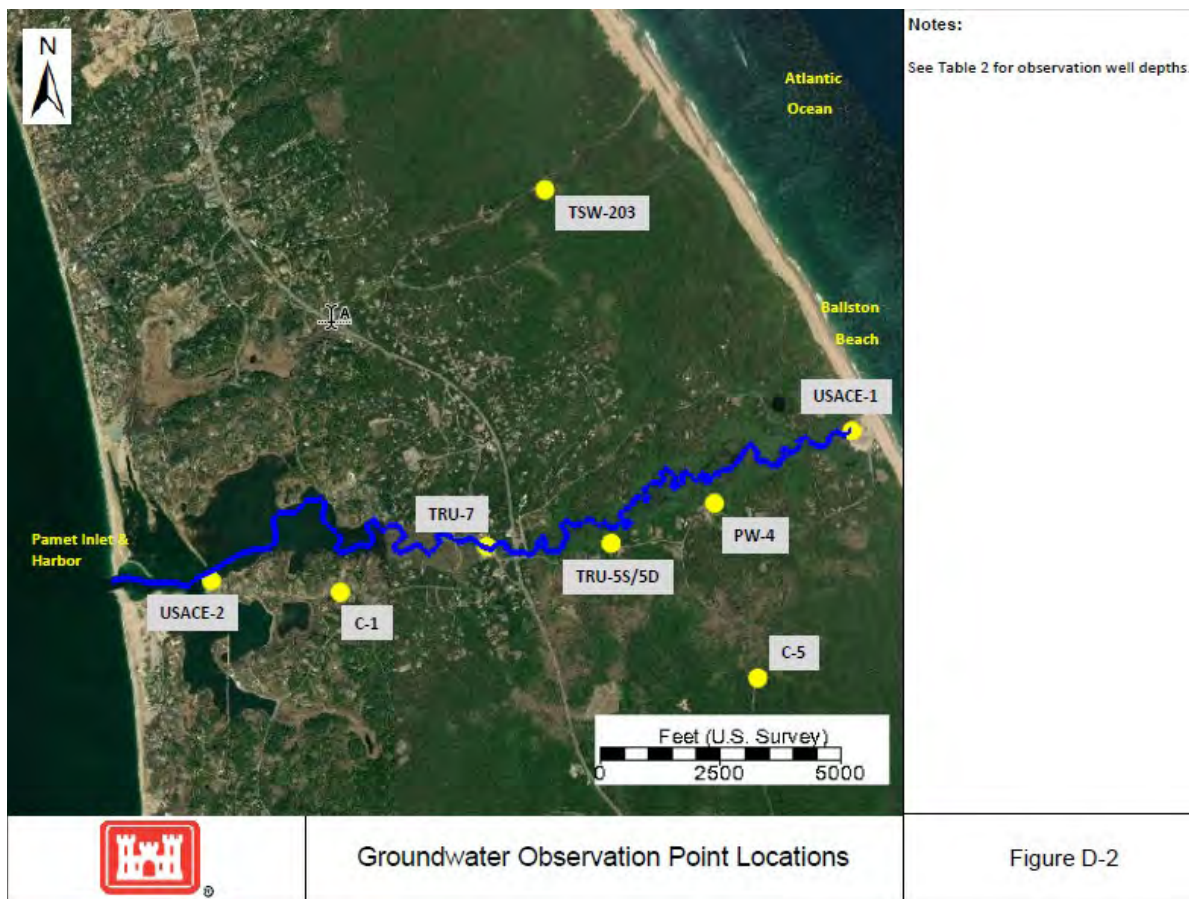
Wells selected as most suitable or usable for use as input data sources for the groundwater / surface water modeling had been installed for previous studies. In total, ten groundwater wells were selected for automated 15 minute data collection of water level and temperature, of which eight were existing wells needing redevelopment. Two wells were new shallow steel wellpoints installed by USACE and designated: USACE-1 (Head of Pamet near Ballston Beach) and USACE-2 (Truro Harbor off Depot Road), both hand driven to 3-4 feet below ground surface and consisting of a 3 ft stainless steel tip and 2-inch diameter steel casing / riser with cap. See Figures B-7 to B-11 (Attachment B) for Station Photos and Figures C-1 to C-50 (Attachment C) for Station Locations. A table presenting a well construction summary and rationale for monitoring is shown in Figure B-12.

**Location Map: Groundwater Monitoring Stations (Attachment D: Figure D-2)**

The two new well points and eight existing monitoring wells were installed and / or redeveloped from January 2017 and February 2018. The eight existing wells installed by the Cape Cod Commission or others, and the two “new” wells, USACE-1 at the head of the Pamet near the tip of the overwash alluvial fan, and USACE-2 at the outflow of the Pamet into Truro harbor. Attachment B, Figures B-13 & B-16, present the Pamet River Well Redevelopment Field Sheets, Figures B-14 & B-15 present the YSI 6020 Real Time Parameter Analysis used during the Well Redevelopment, and Figures B-17 & B-18 present the Pamet River Well Logger deployment.

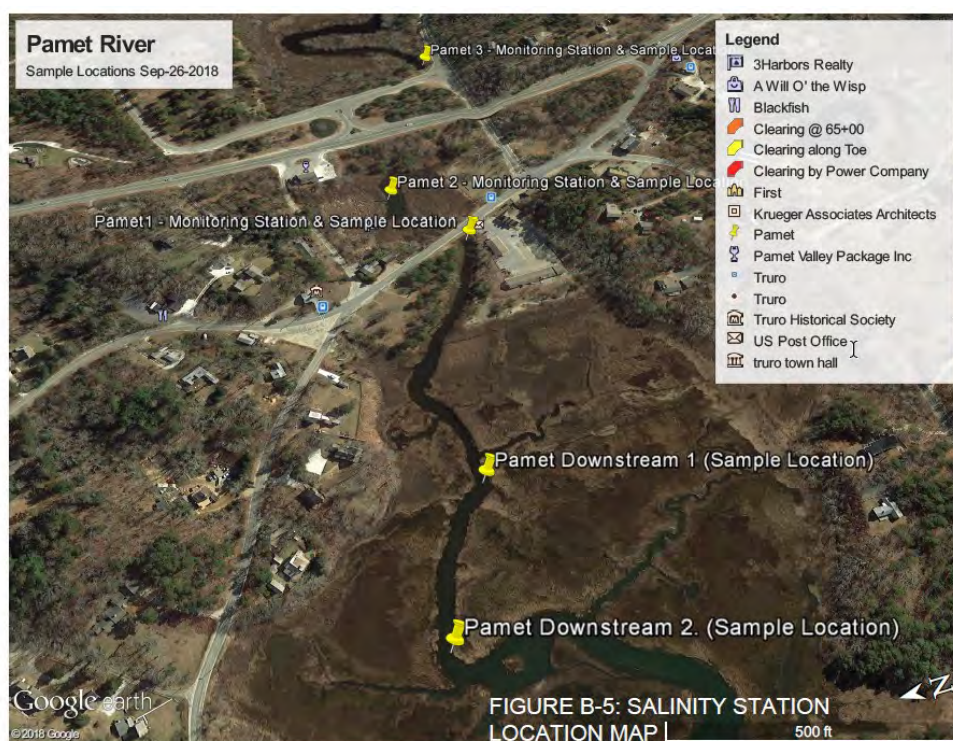
Per the removal of the Wilder's Dike tide gate during the March 2018 nor'easter, the August 2018 field data was scheduled to be collected before the tide gate was replaced on August 14, 2018. The absence of the tide gate for approximately five months from March to August 2018 afforded a unique opportunity to obtain the surface water grab samples from the Pamet River to determine the extent of tidal salt prism migration upstream of Wilders Dike. Surface water grab samples collected at the same stations after the tide gate was replaced provided field verification to calibrate the HEC-RAS model and upper Pamet salt marsh restoration potential.

Location Map: Salinity Grab Sample Stations (Attachment B: Figure B-5)

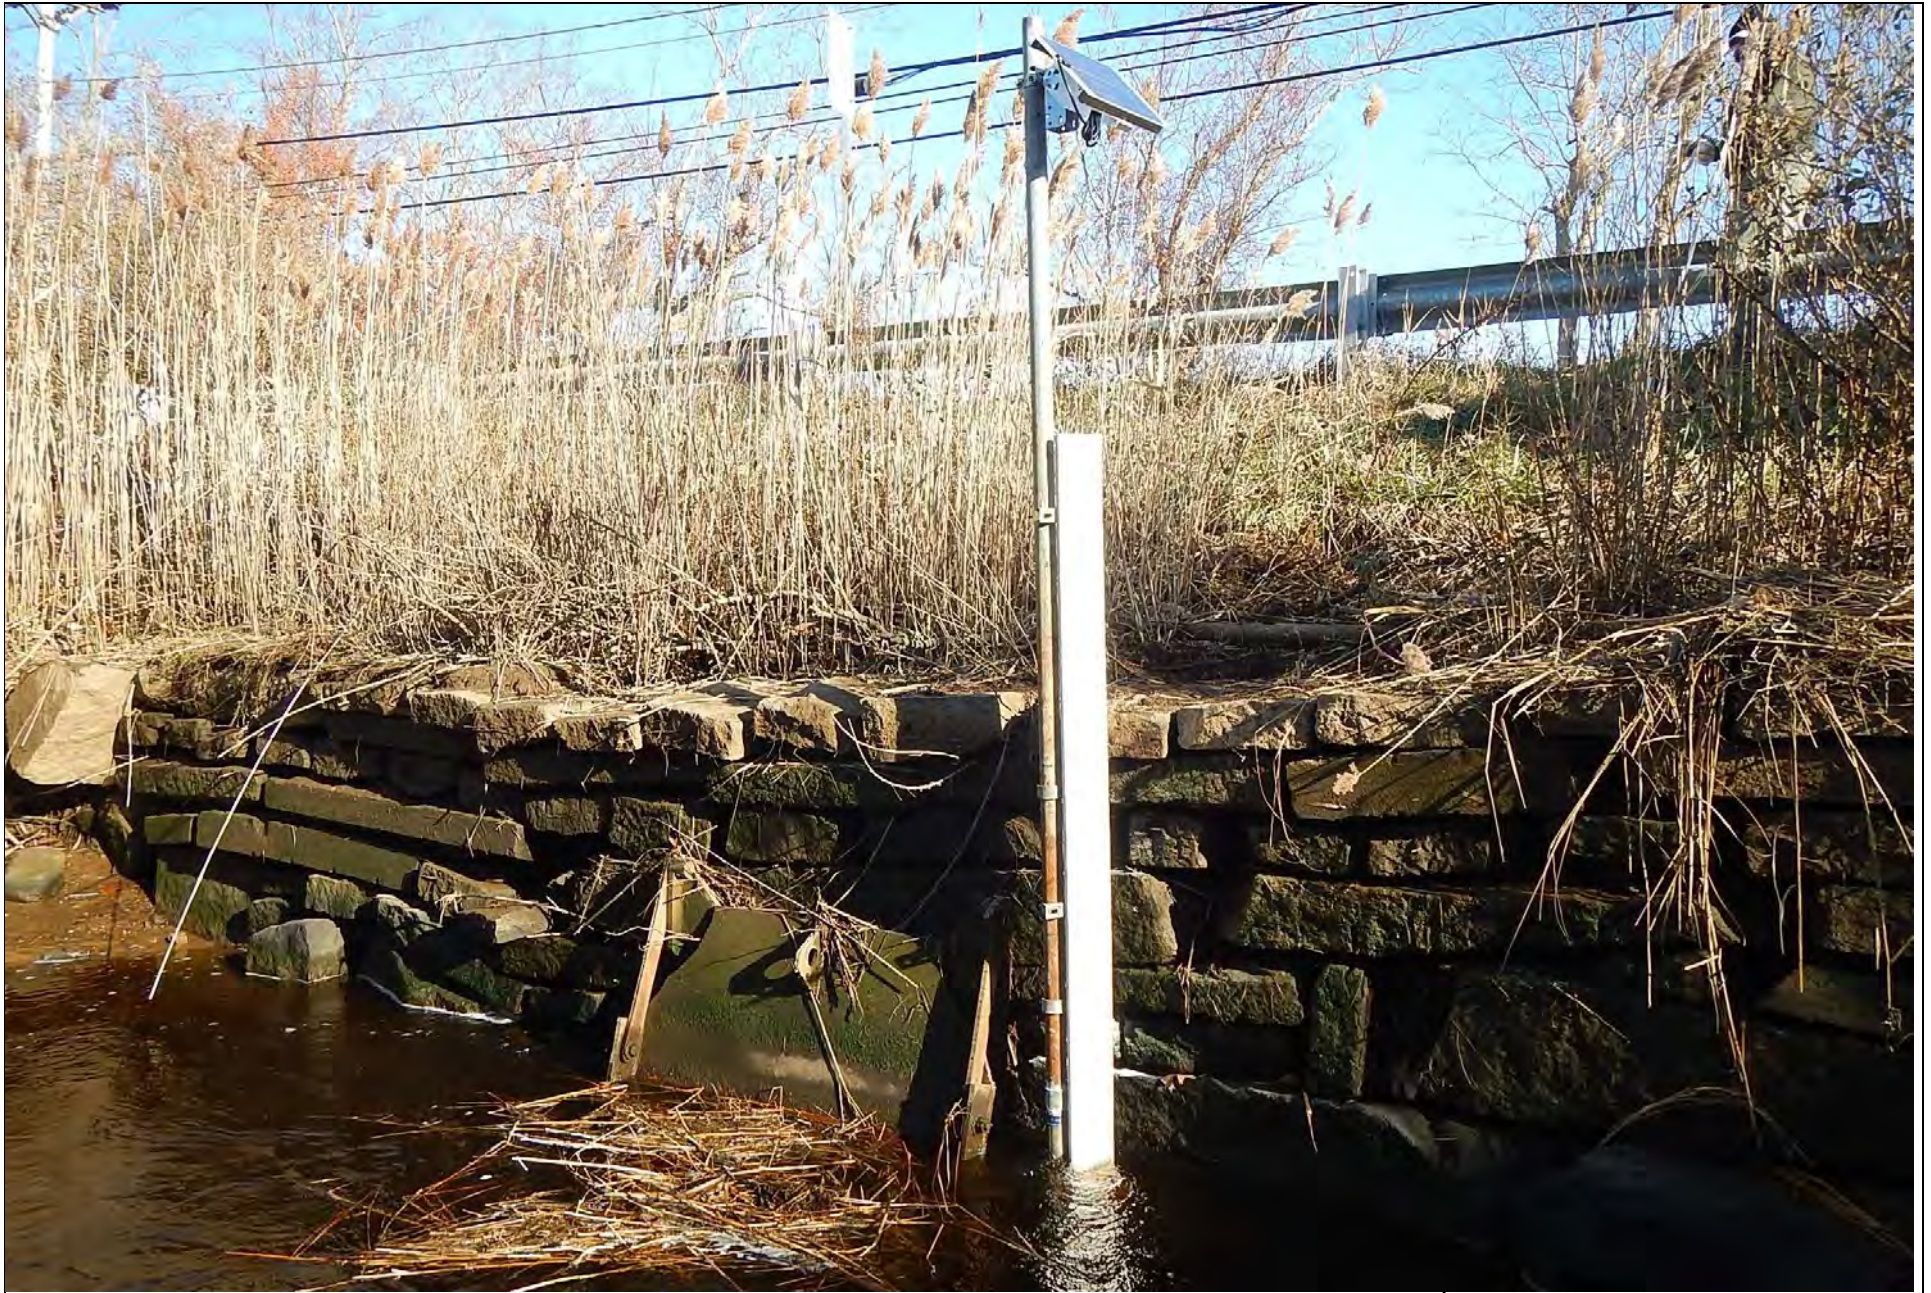
Figure B-2

Pamet 1 Tide Gage (Photo December 2016)

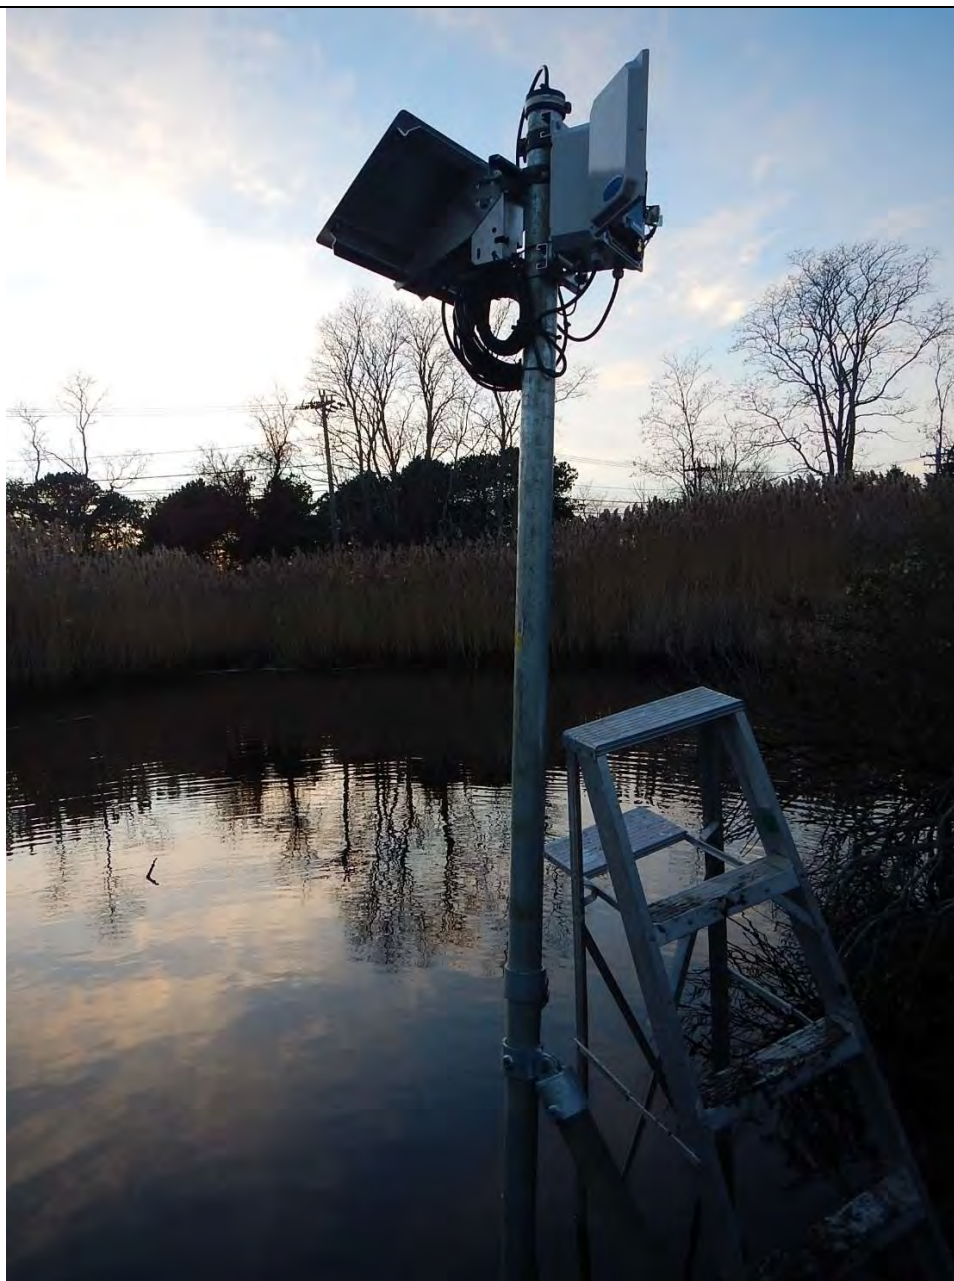
Figure B-3

Pamet 2 Tide Gage (Photo December 2016)

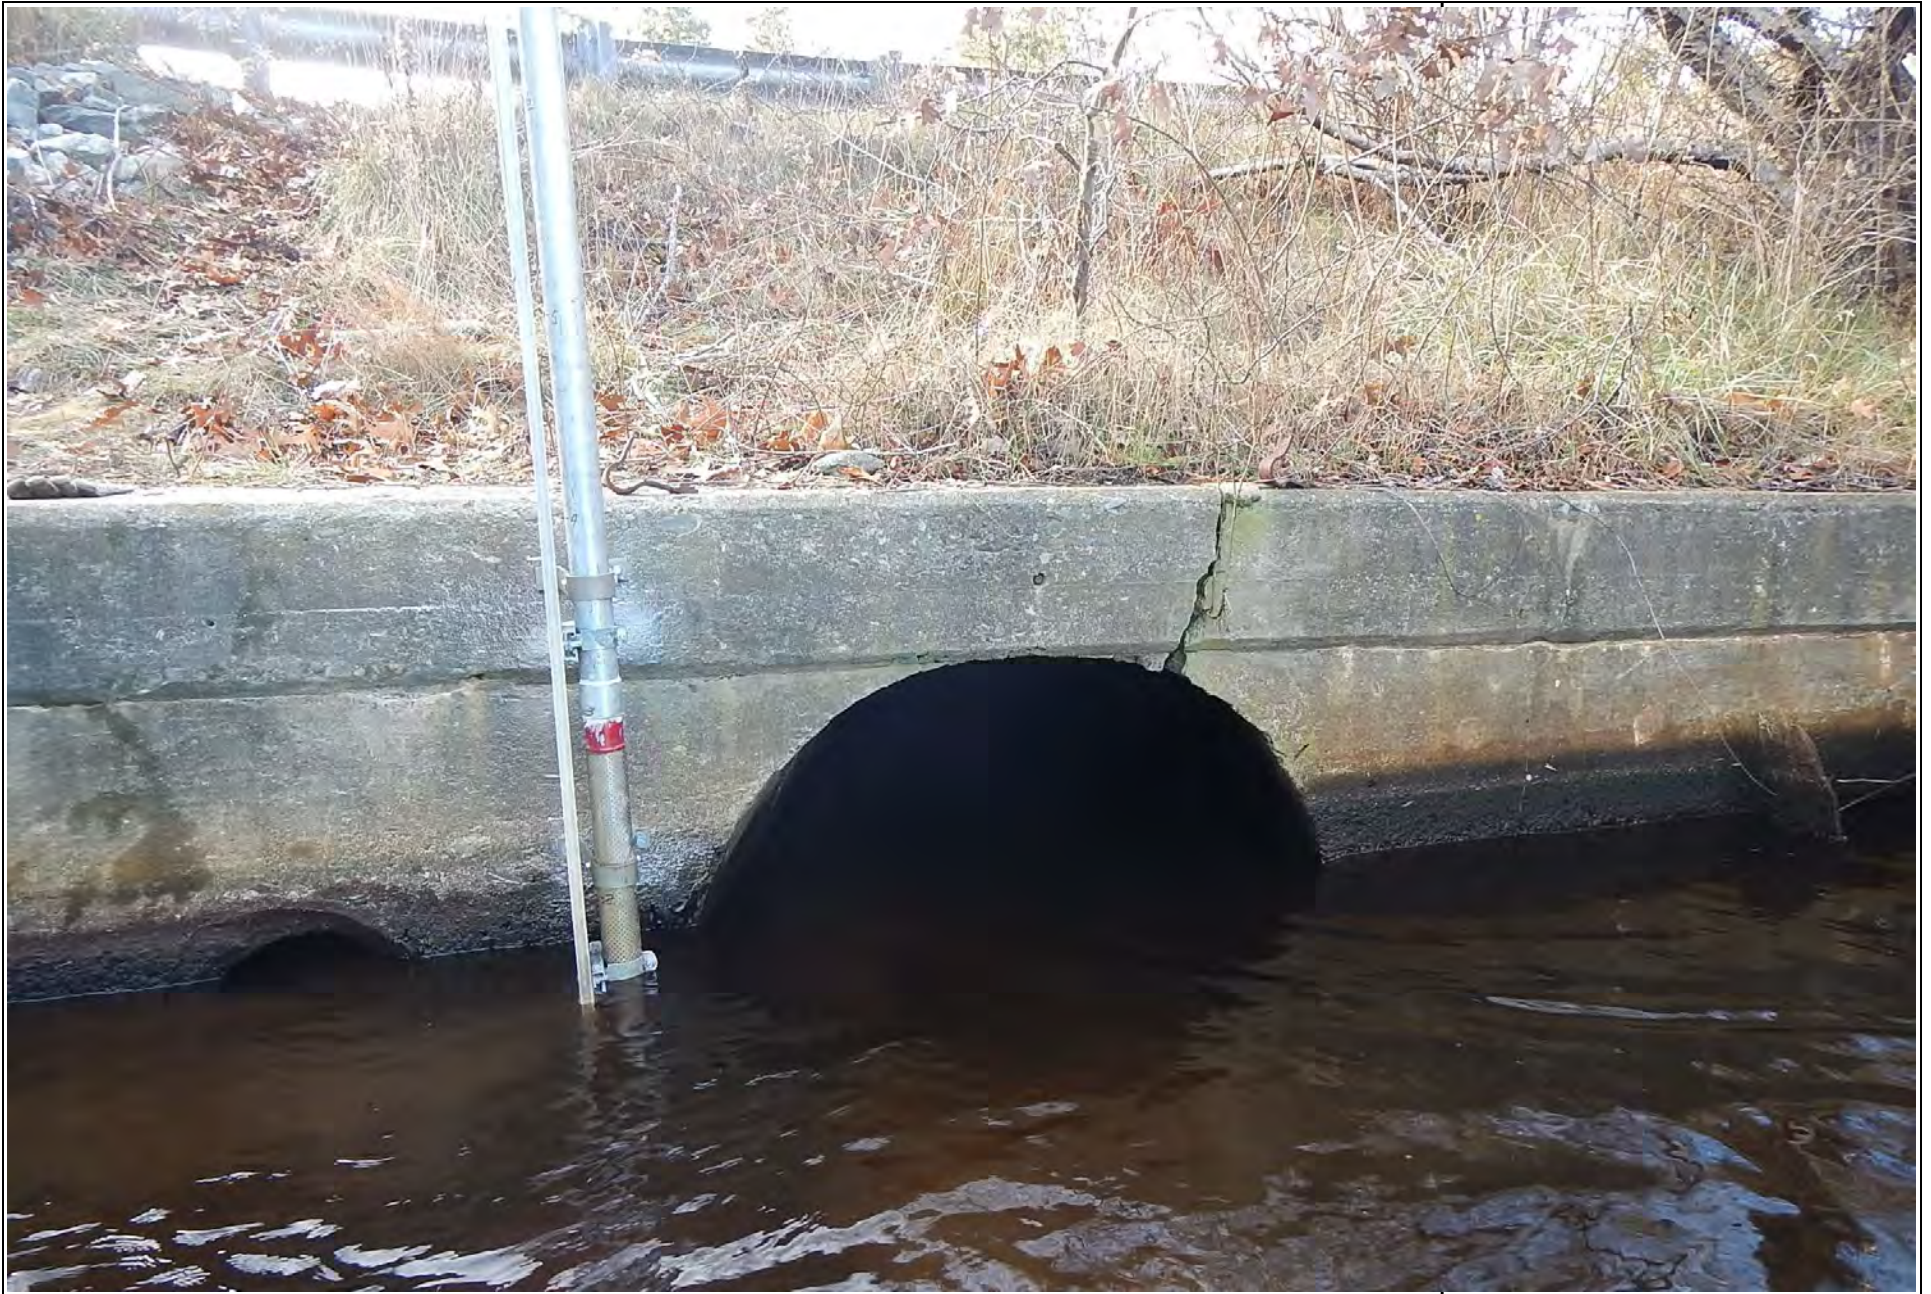
Figure B-4

Pamet 3 Tide Gage (Photo December 2016)

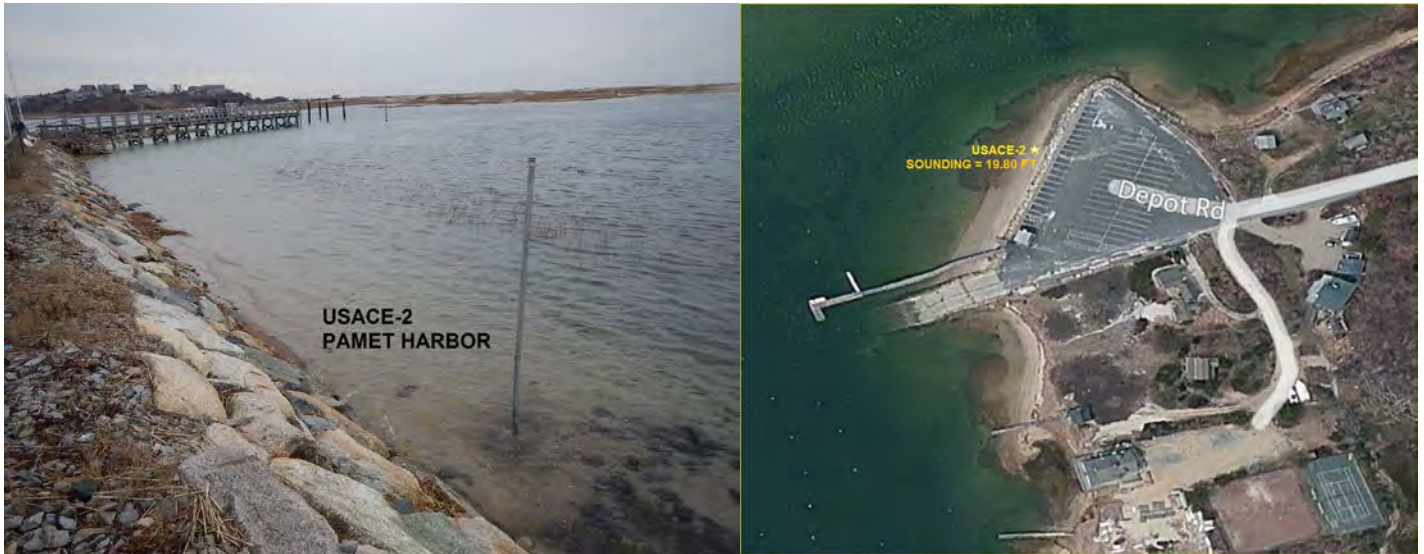
USACE-2      This well, also composed of a capped 2 inch diameter galvanized steel pipe, extends about 19.5 feet above ground just sea ward of the Pamet Harbor breakwater. Obviously it can only be accessed at low tide with a ladder.

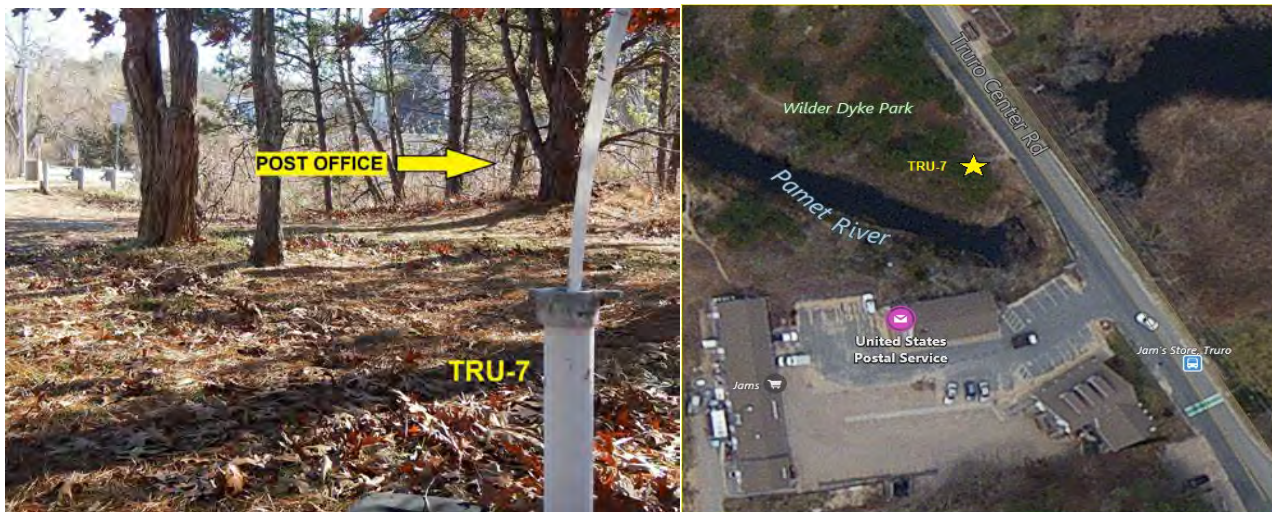
FIGURE B-8

TRU-7      This well is a 2 inch diameter PVC pipe standing 1.7 ft agl. It sits within the confines of the Wilder Dyke Park on Truro Center Road near the U.S. Post Office.

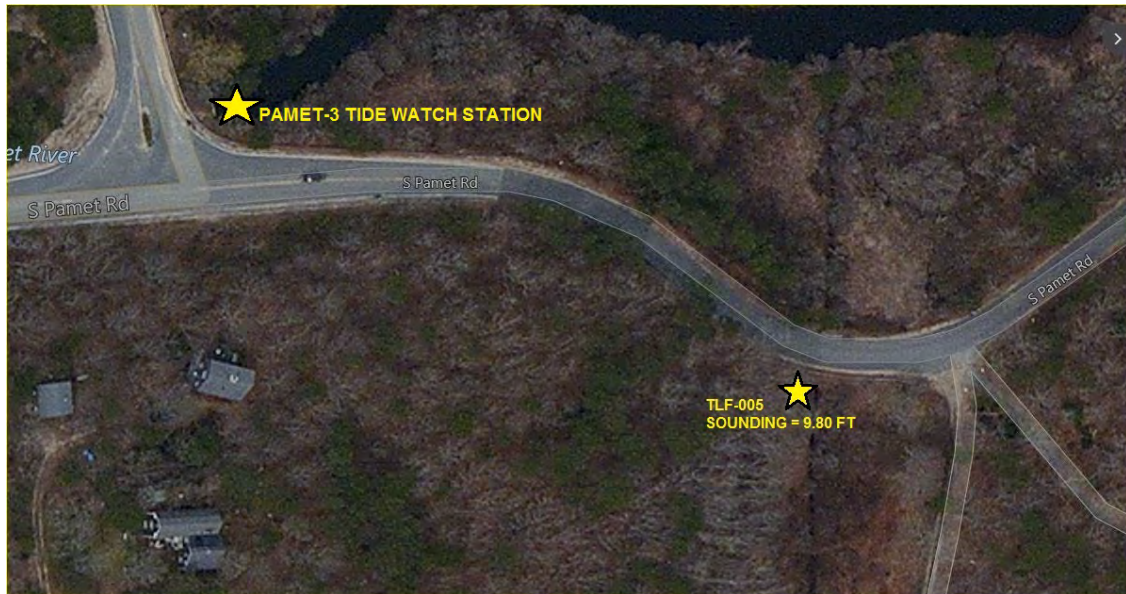
TLF-005 This well is a 1 inch diameter gray PVC pipe standing just over 1 ft agl. It's located on a curve on the South Pamet Road about 15 ft below the guard rail and next to a stream. A rubber plumbing cap secures the opening with a hose clamp that requires a common blade screwdriver.

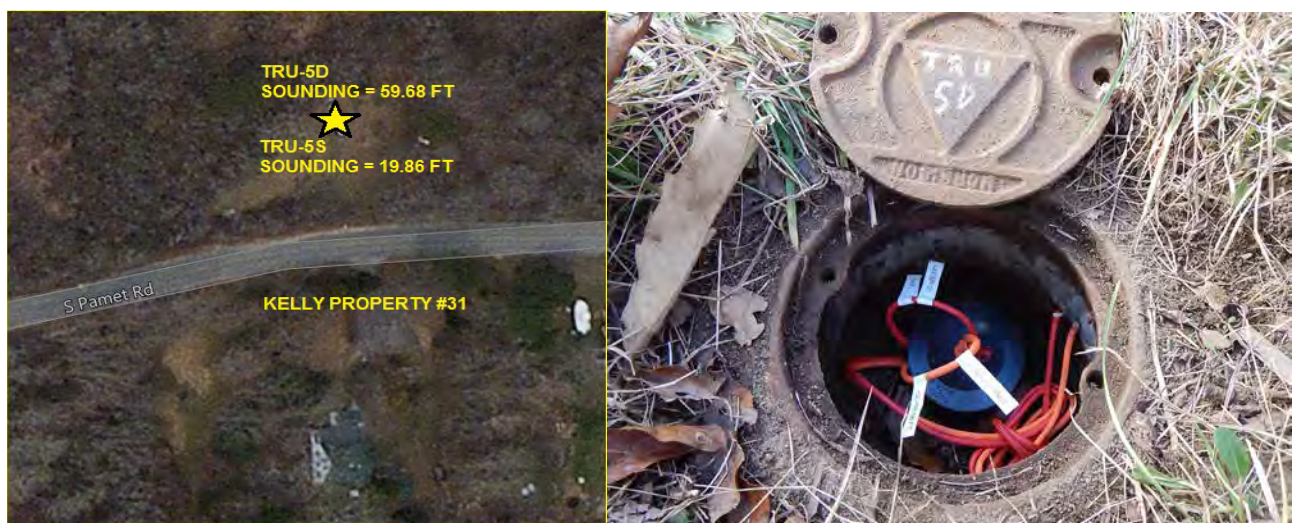
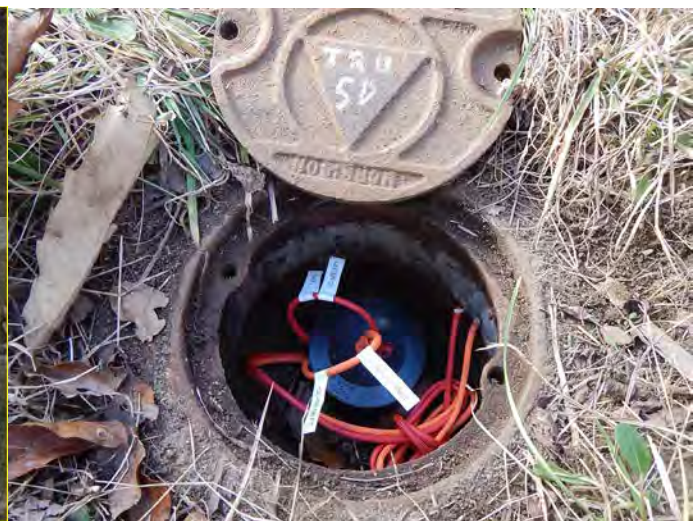
FIGURE B-9

TRU-5 These wells are 2 inch diameter PVC pipe in flush-mounted casings. Proceeding along S. Pamet Rd. from TLF-005 they sit on the Kelly property at 31 S. Pamet at the back of the field opposite the house driveway. A white mail box marks the entrance to the field. A ½ socket will be necessary to unbolt the covers.

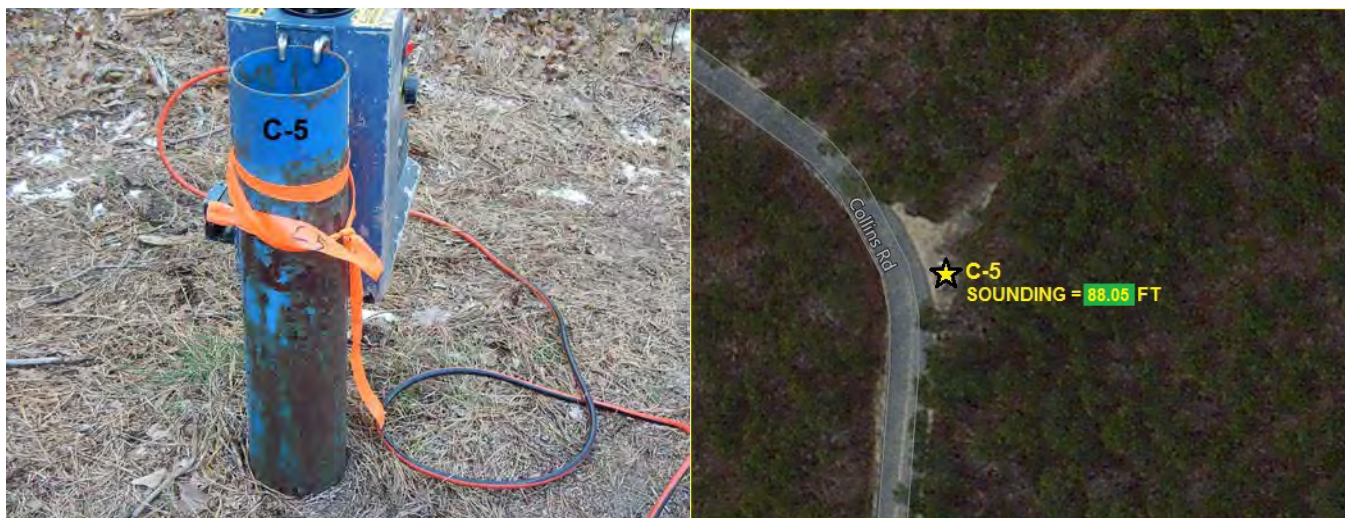
C-5 This well on Collins Rd., which leads right off of S. Pamet, sits on a curve at the entrance to Fire Rd. #3 in plain sight. At about 1.5 ft agl, it holds a 2 inch diameter PVC pipe in 4 inch diameter steel casing with a key lock.

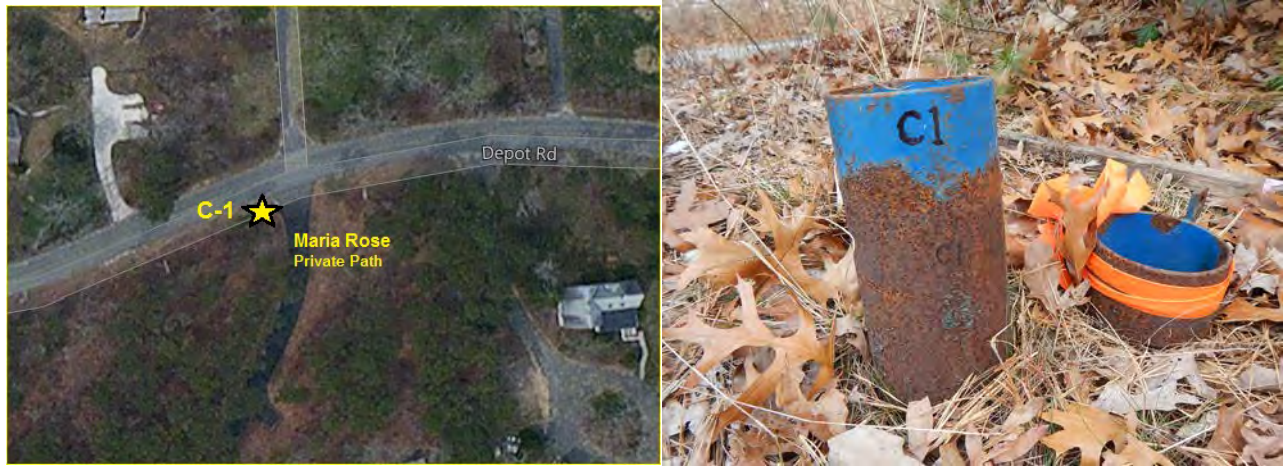
FIGURE B-11

C-1 South of the Post Office, Depot Rd. bears to the right and leads to Pamet Harbor. Stay to the right at the next fork and the well will be on your left at the corner of Depot Rd. and Maria Rosa (Private Path). This is another 2 inch PVC pipe inside a 4 inch dia. 1 ft tall steel casing with a pad lock.

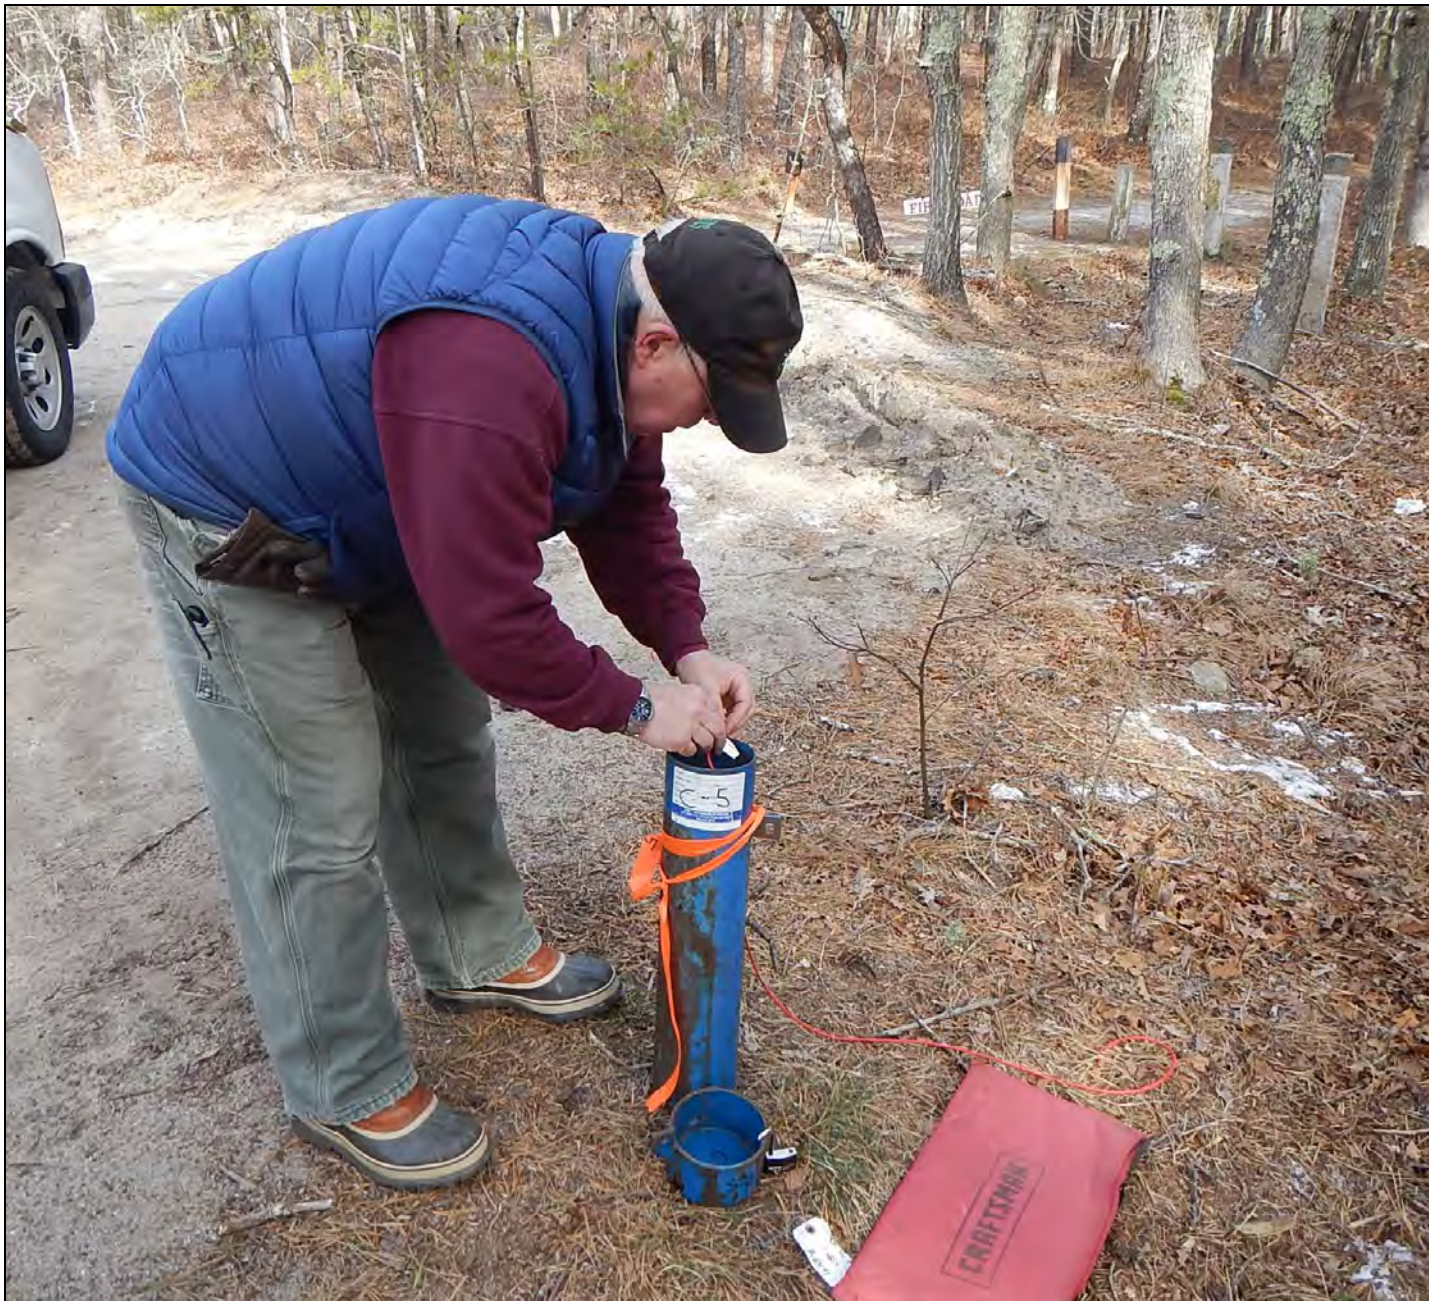
Figure C-1

Well C-5 is located about 0.85 miles south of the Pamet River on the ocean side of the Cape Cod Peninsula. The ground surface at this location is approximately 70 ft above NAVD88. The depth of this well is 90 ft.

C-5 (Figure 8 Attachment D) is located three-quarters of a mile south of the river and far from the influence of river stages. The model over-predicts heads at this well by 3-4 feet during the February and April models. No data was collected in January at this well. The reason for this large residual could be a significant difference in geology or recharge south of the river as compared to north of the river. There was no data to support the large difference in parameters that would be required for the model to match both this well and TSW-203. It is also possible that the depth or location of the well are not known precisely or an error was made in measuring the depth of the pressure transducer which was used to measure the heads in the well.

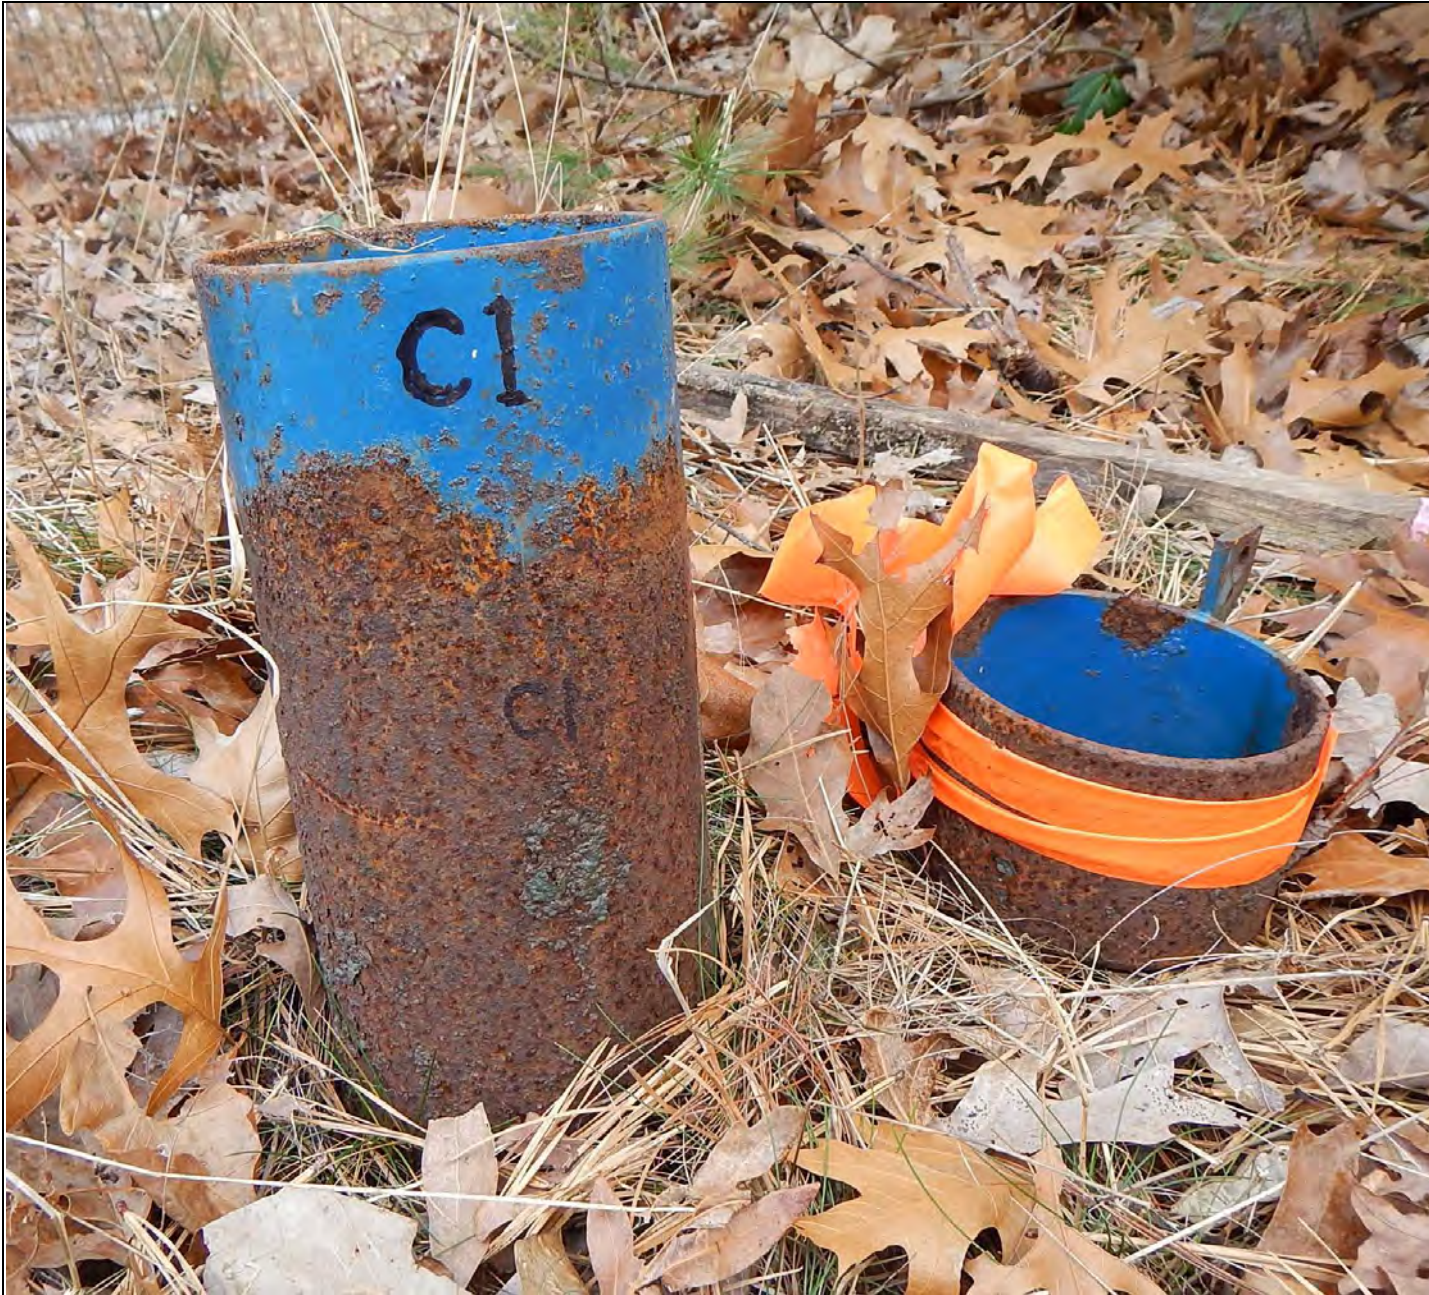
Figure C-6

Well C-1 is located downstream of Route 6 about 0.15 miles south of Pamet River on a small hill with a casing elevation of 32.8 ft. The depth of the well is 40 ft.

C-1 (Figure 7 Attachment D) is located 900 feet south of the tidal section of the river, but does not have a tidal signature in the head data. The model under-predicts heads at this well by up to about 1 foot during the February and April models. No data was collected in January at this well.
