## SECTION 22 - PLANNING ASSISTANCE TO STATES PROGRAM

# Pamet River Investigation Truro, Massachusetts

November 2019

US Army Corps  
Of Engineers  
New England District

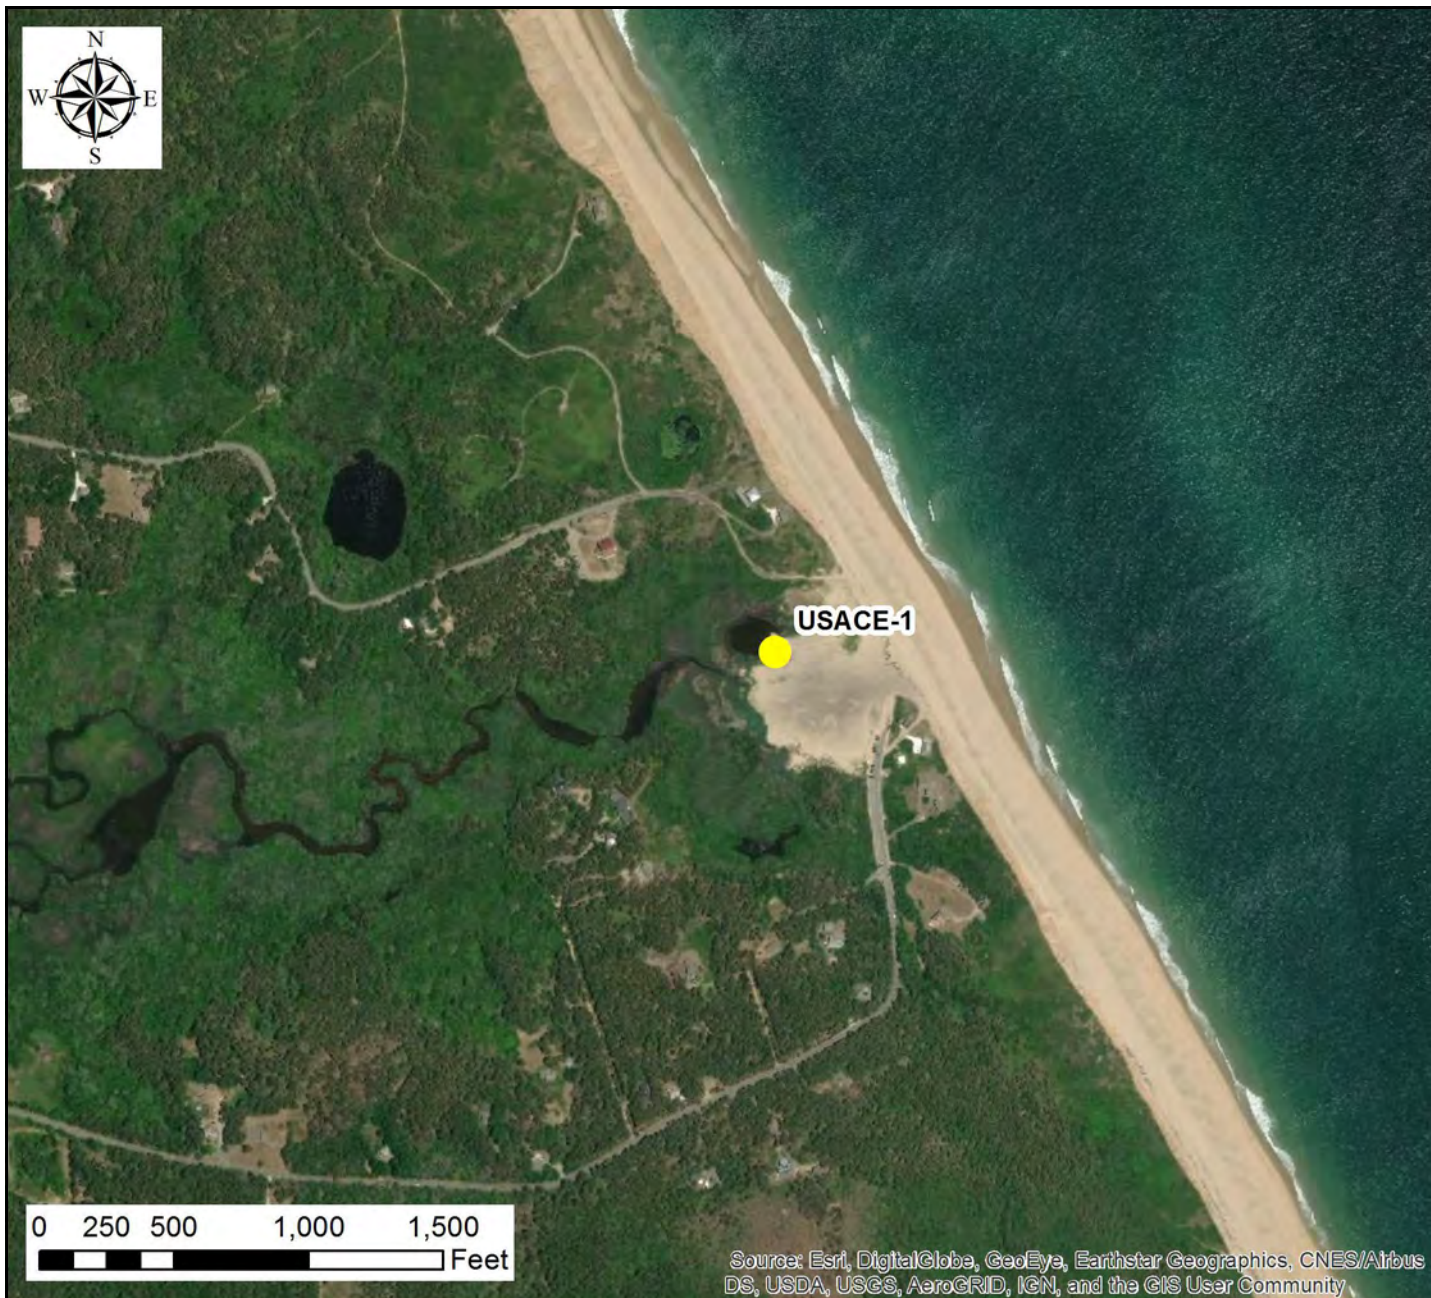
Figure C-10

Well USACE-1 is located just inland from Ballston beach near the head of the Pamet River. The casing elevation is 7.5 feet above NAVD88. It was driven by hand about 7 feet into the sand.

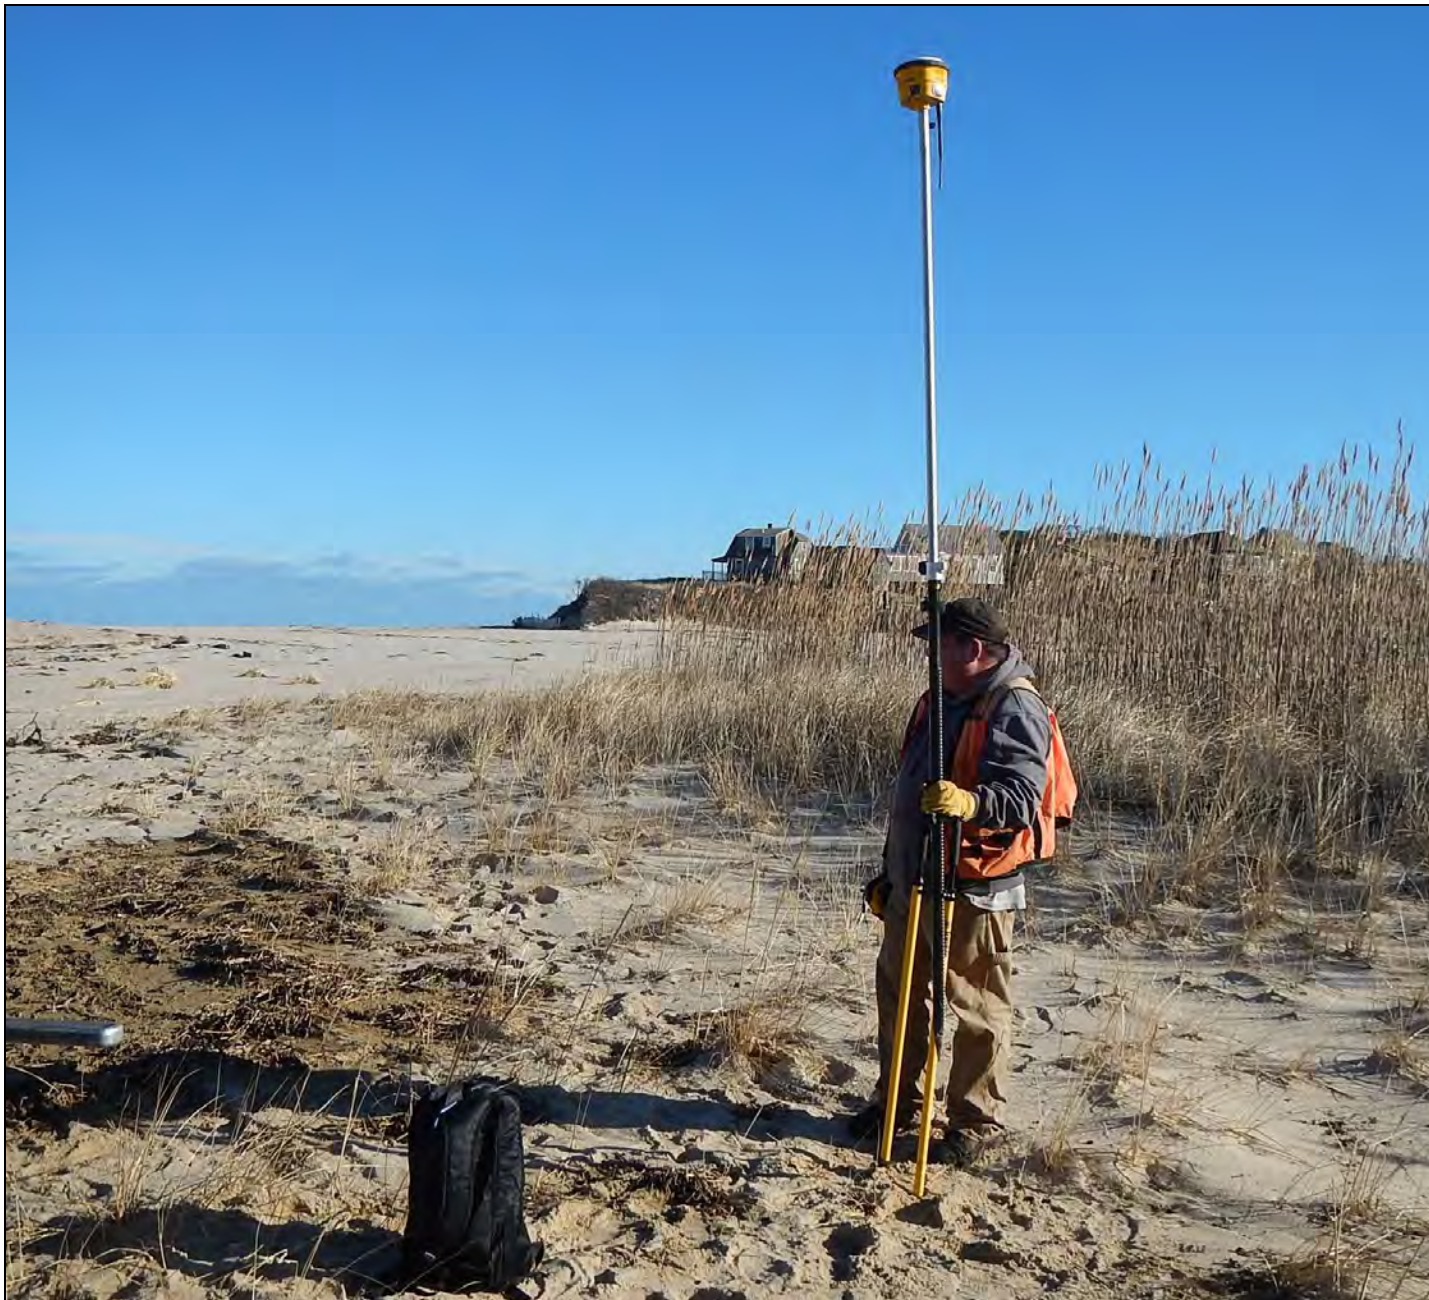
Figure C-11

Well USACE-1 is located just inland from Ballston beach near the head of the Pamet River. The casing elevation is 7.5 feet above NAVD88. It was driven by hand about 7 feet into the sand.

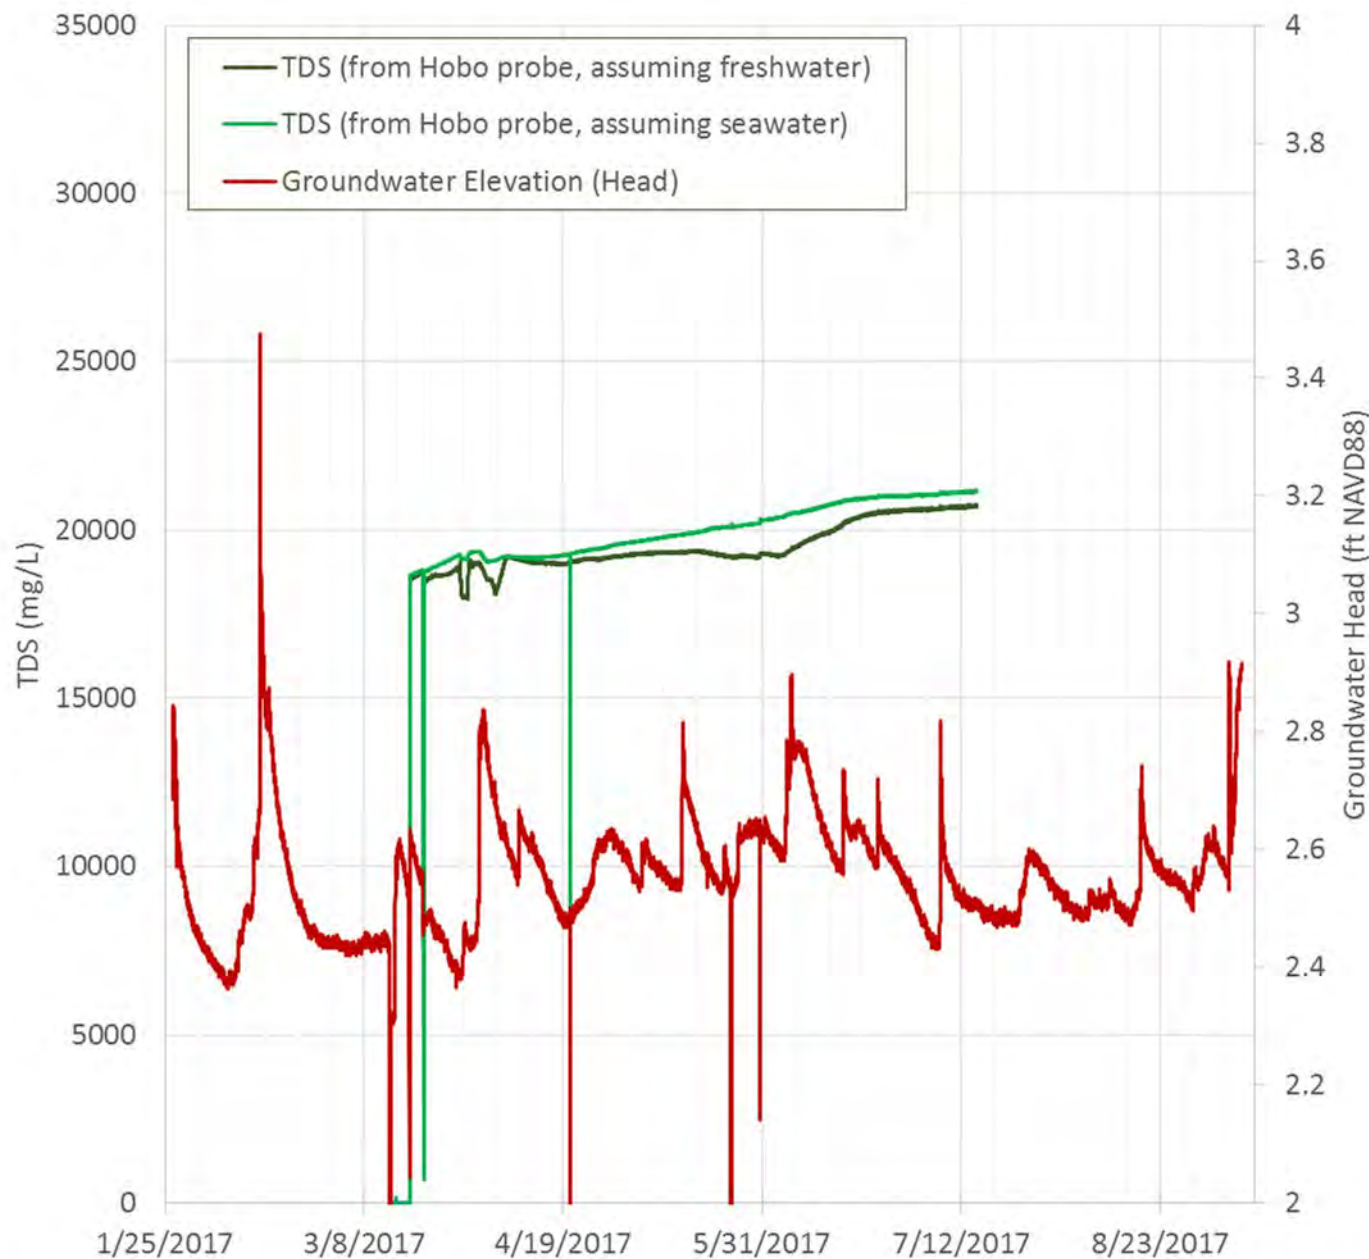
Figure C-13

The total dissolved solids (TDS) for this well is partway between freshwater and seawater. Two options are available for converting the Hobo output to TDS. Because this groundwater is neither fresh nor as saline as seawater, both options are presented. The difference between the results is minimal.

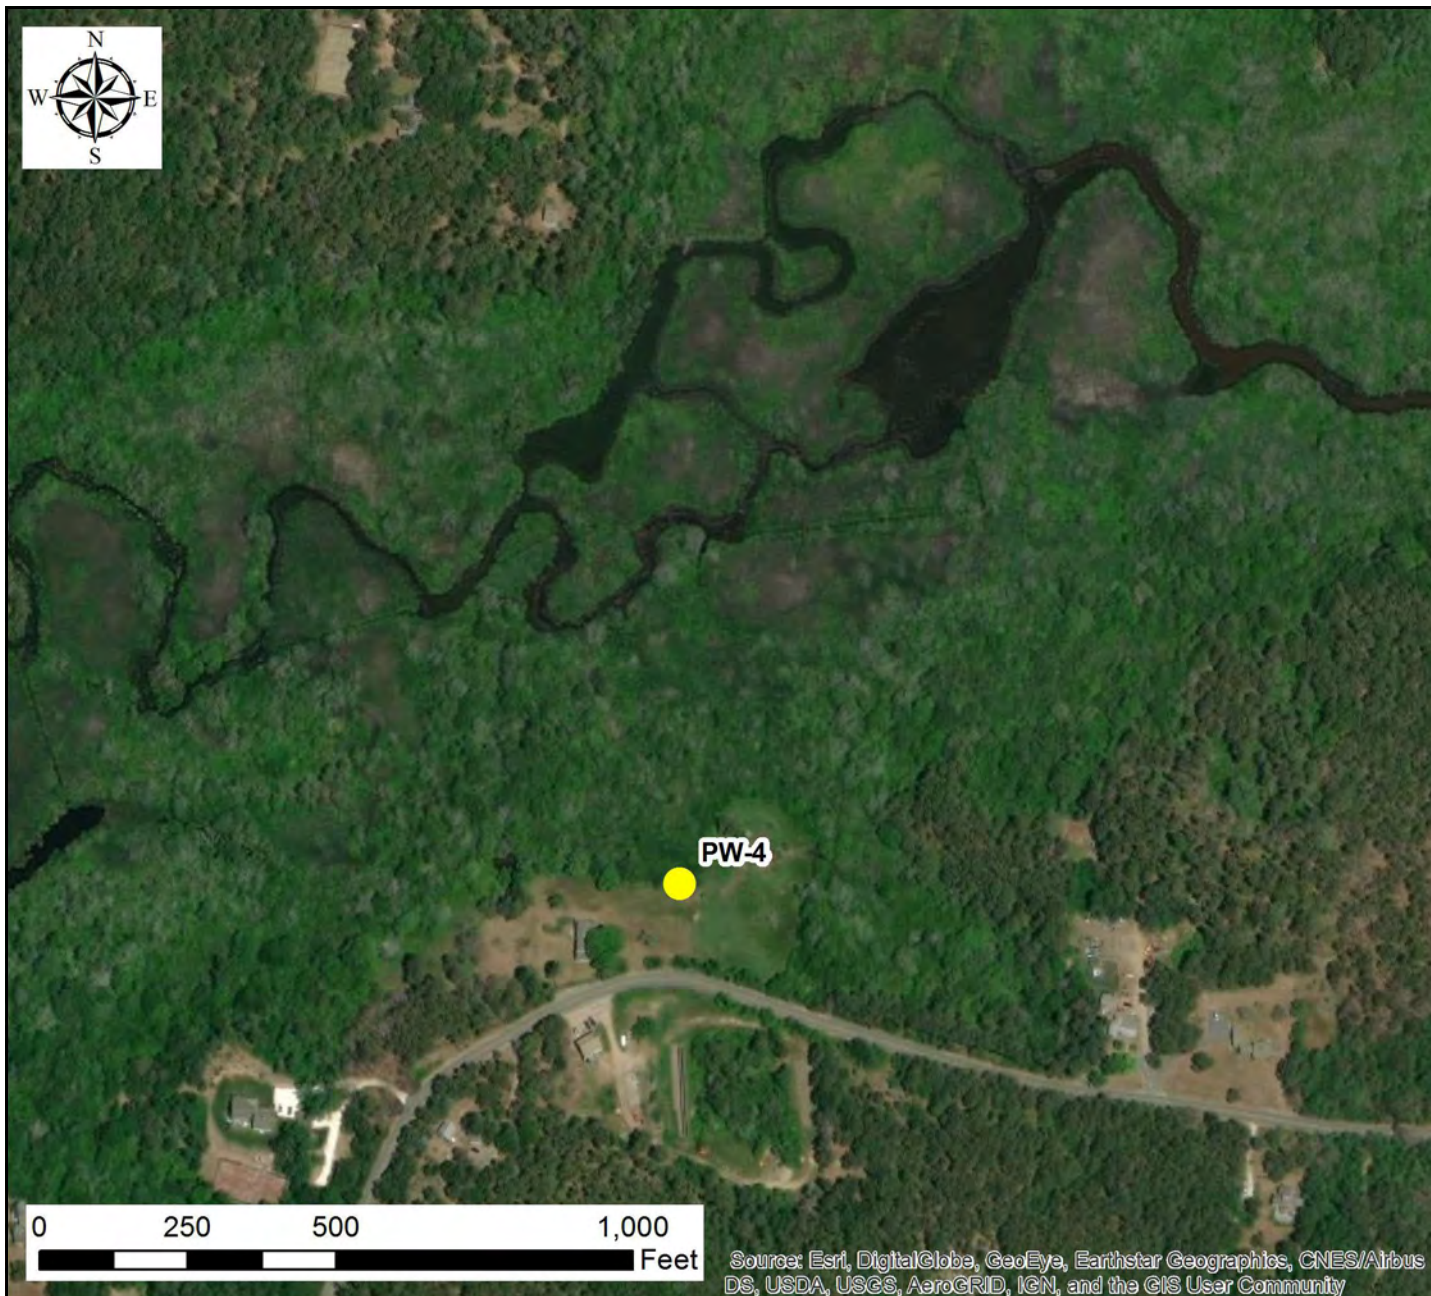
Figure C-15

Well PW-4 is located in a low-lying area (ground surface about 1 ft above NAVD88) about 0.1 miles south of the non-tidal section of the Pamet River. The depth of this well is 38.56 ft. This well is co-located with PW-3D.

PW-4 (Figure 9 Attachment D) is located about 400 ft south of the non-tidal section of Pamet River. The groundwater model reproduced heads at this well within less than 0.5 ft. The model results show a very small tidal signature which does not appear in the observed data.

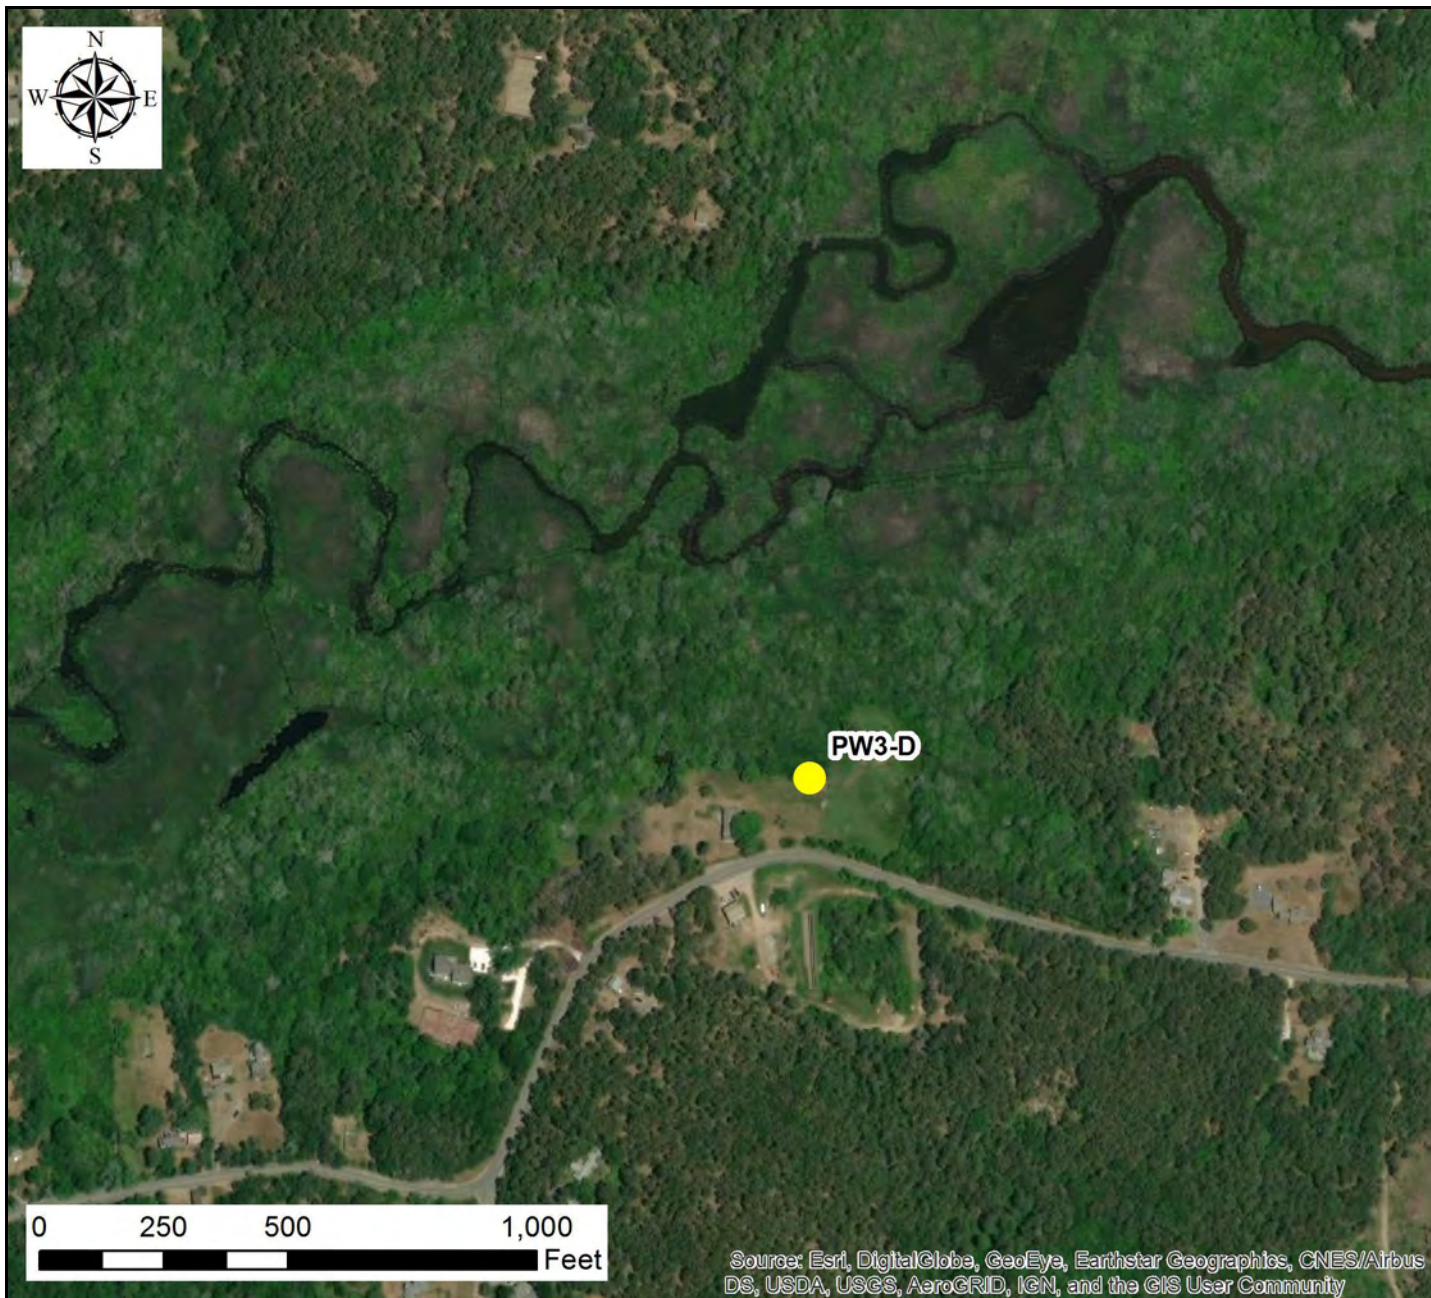
Figure C-20

Well PW-3D is located in a low-lying area (ground surface about 1 ft above NAVD88) about 0.1 miles south of the non-tidal section of the Pamet River. The depth of this well is 150 ft, making it the deepest well in the dataset. This well is co-located with PW-4.

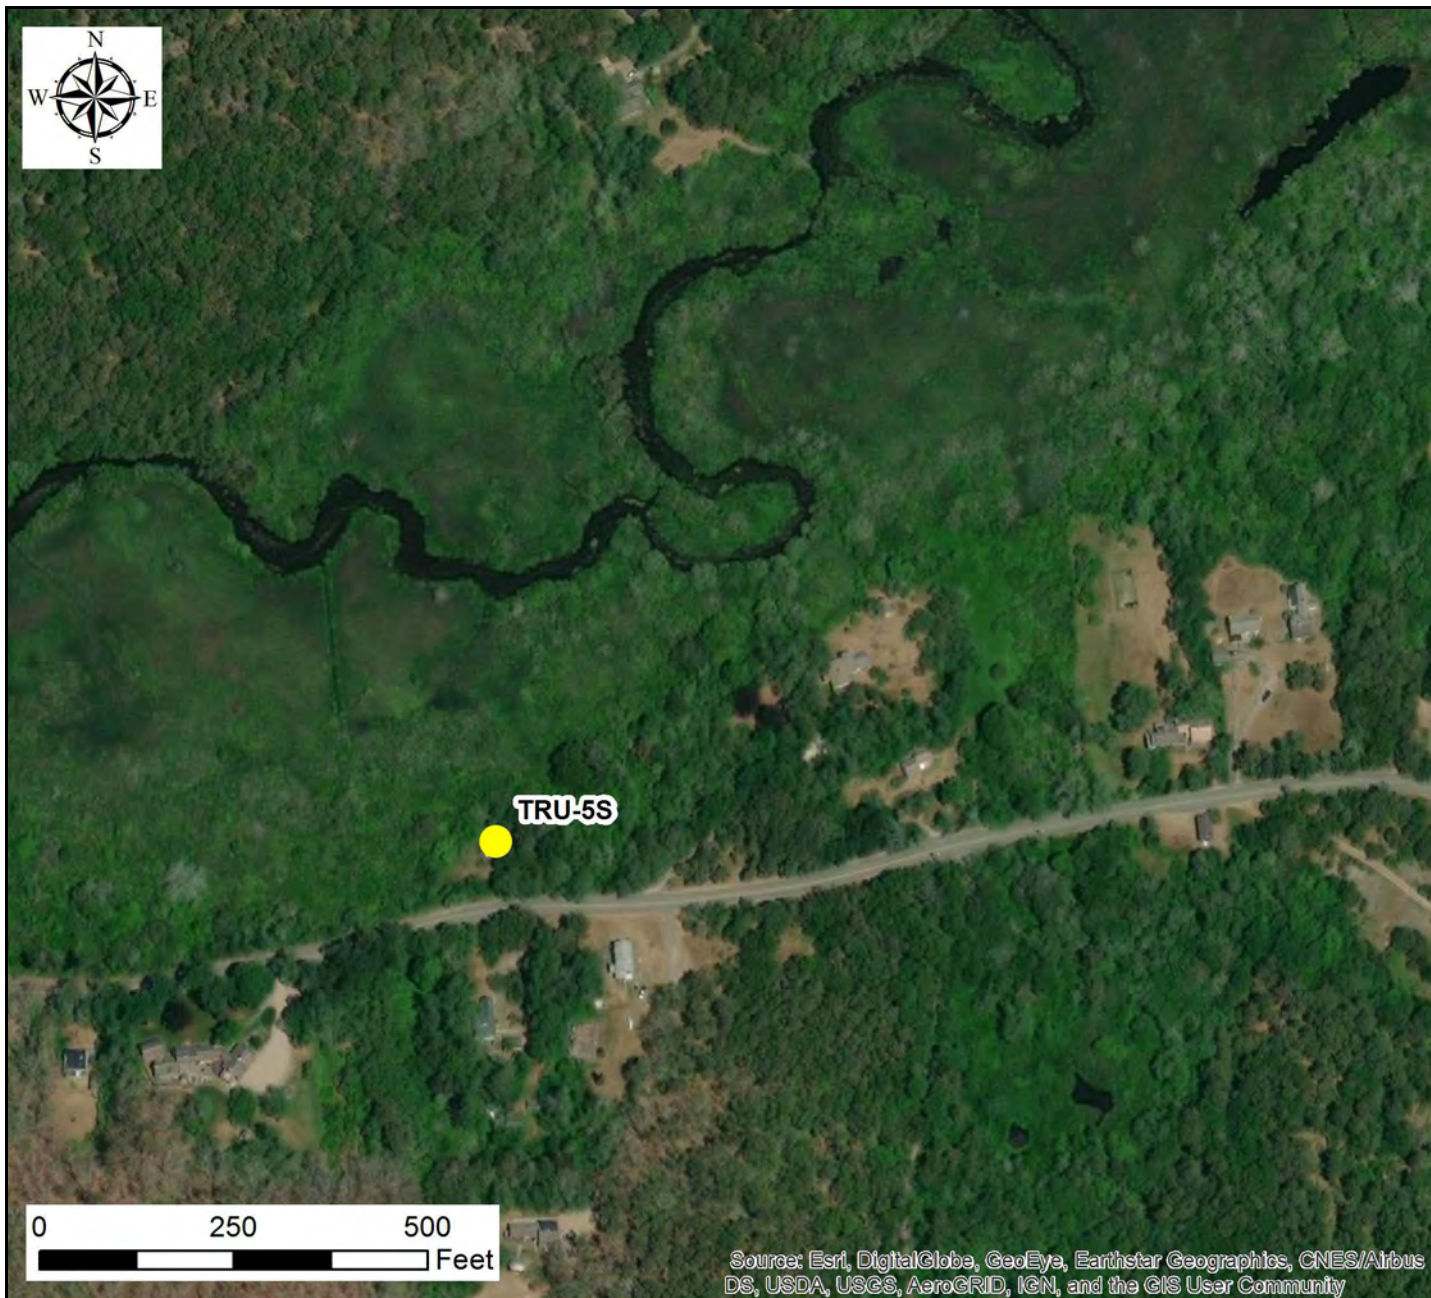
Figure C-26

Well TRU-5S is located about 2500 ft upstream of the dike at the edge of the wetlands south of the Pamet River. The ground surface elevation is about 6 ft above NAVD88 and the depth of the well is 20 ft. This well is co-located with TRU-5D.

TRU-5S (Figure 11 Attachment D) and TRU-5D (Figure 10 Attachment D) are a collocated pair of wells located about 350 ft south of the non-tidal section of Pamet River, between PW-4 and Wilder's Dike. The groundwater model reproduced heads at both these wells within 1 ft. The model results show a very small tidal signature which does not appear in the observed data.

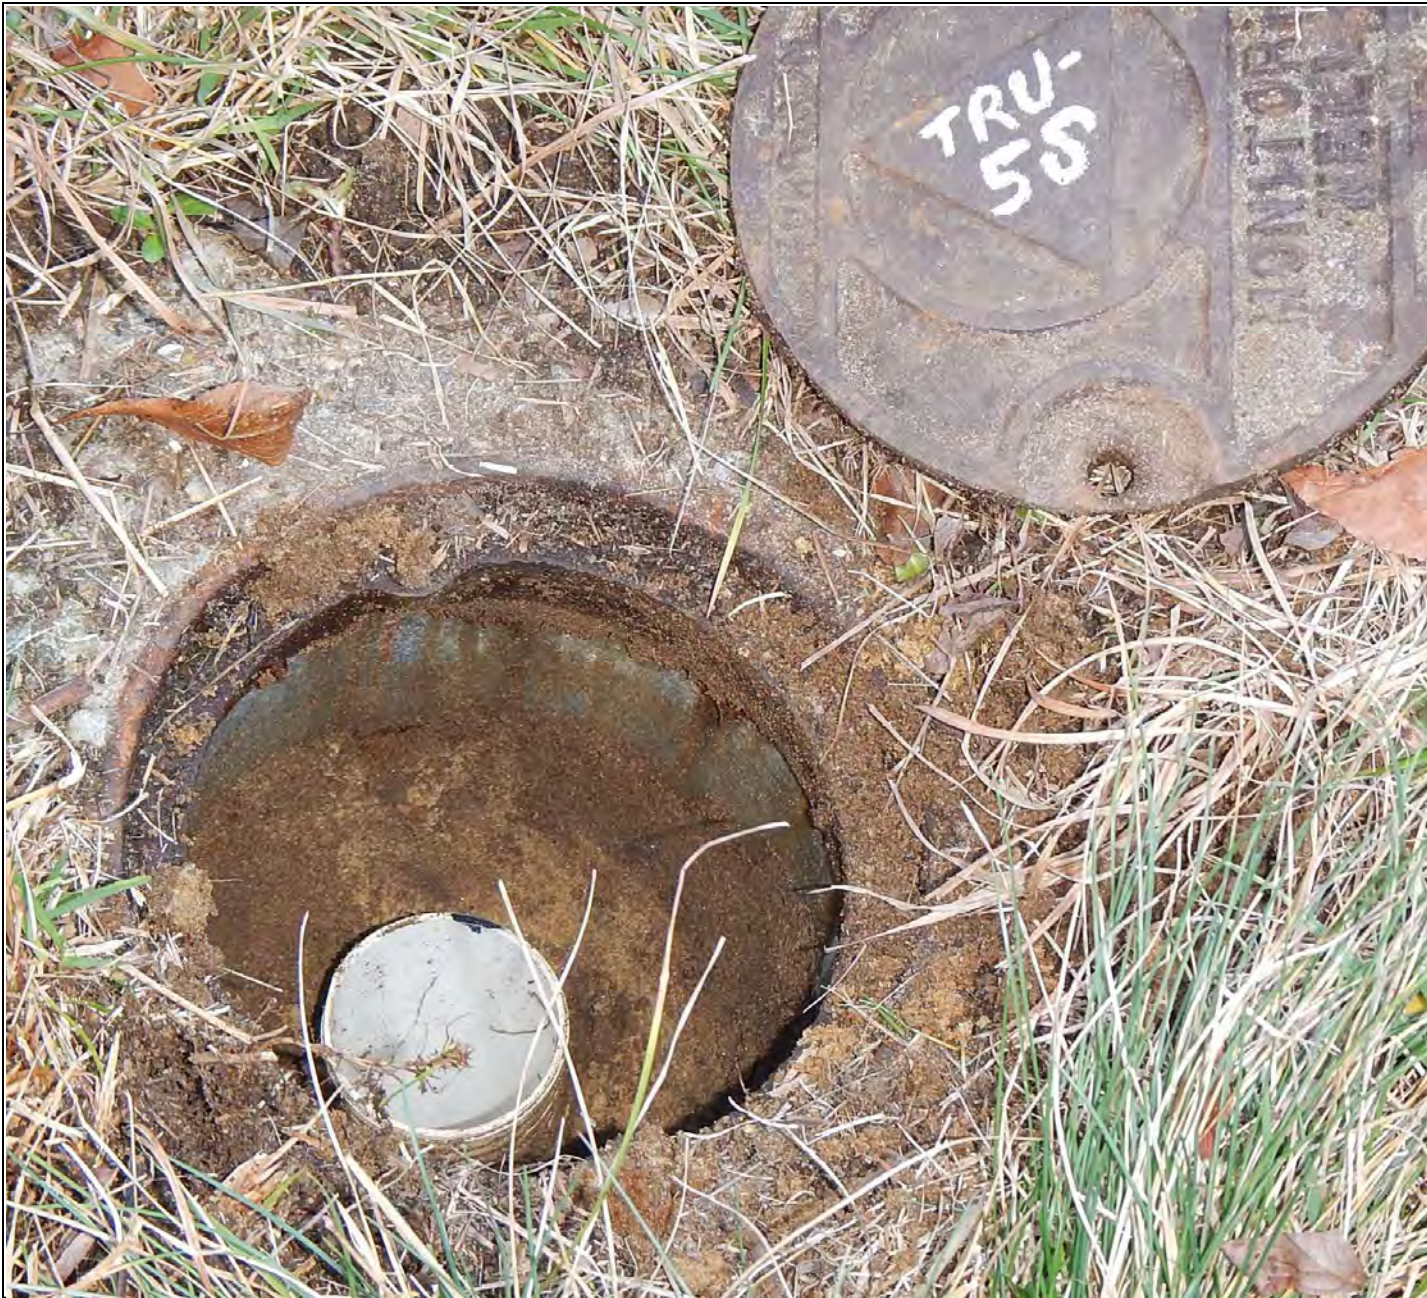
Figure C-27

Well TRU-5S is located about 2500 ft upstream of the dike at the edge of the wetlands south of the Pamet River. The ground surface elevation is about 6 ft above NAVD88 and the depth of the well is 20 ft. This well is co-located with TRU-5D.

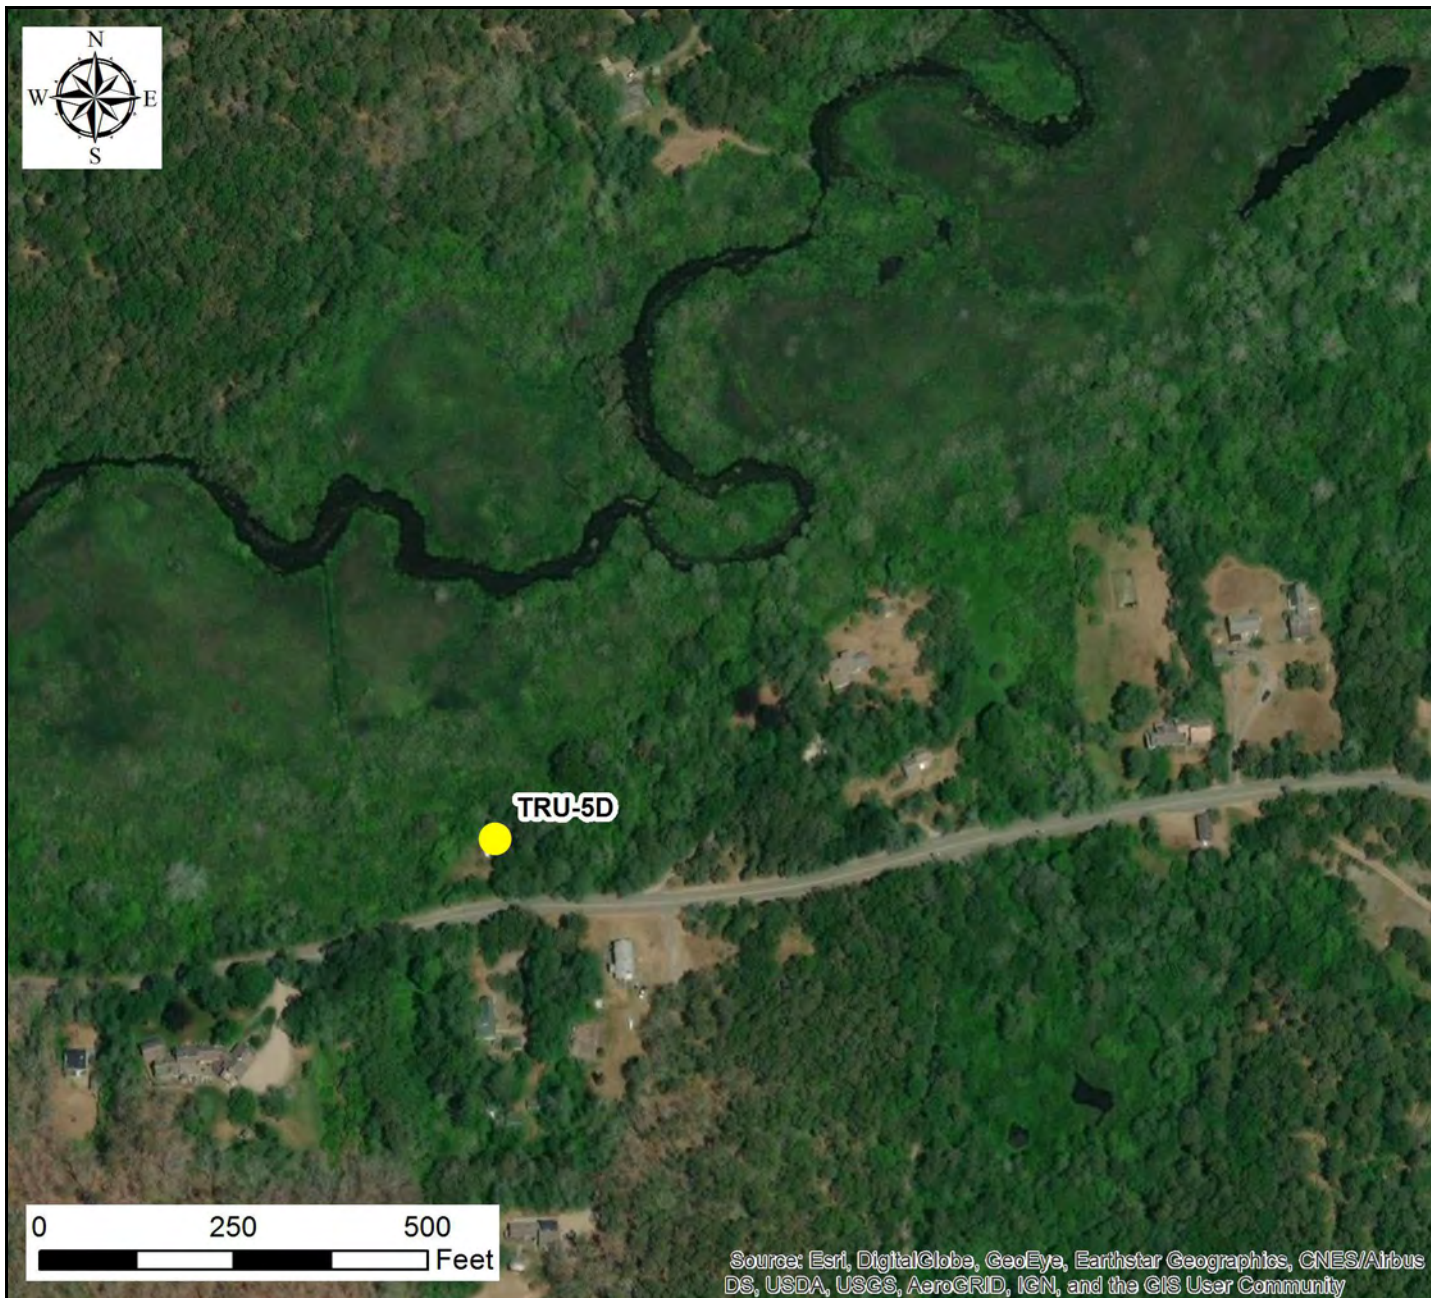
Figure C-31

Well TRU-5D is located about 2500 ft upstream of the dike at the edge of the wetlands south of the Pamet River. The ground surface elevation is about 6 ft above NAVD88 and the depth of the well is 60 ft. This well is co-located with TRU-5S.

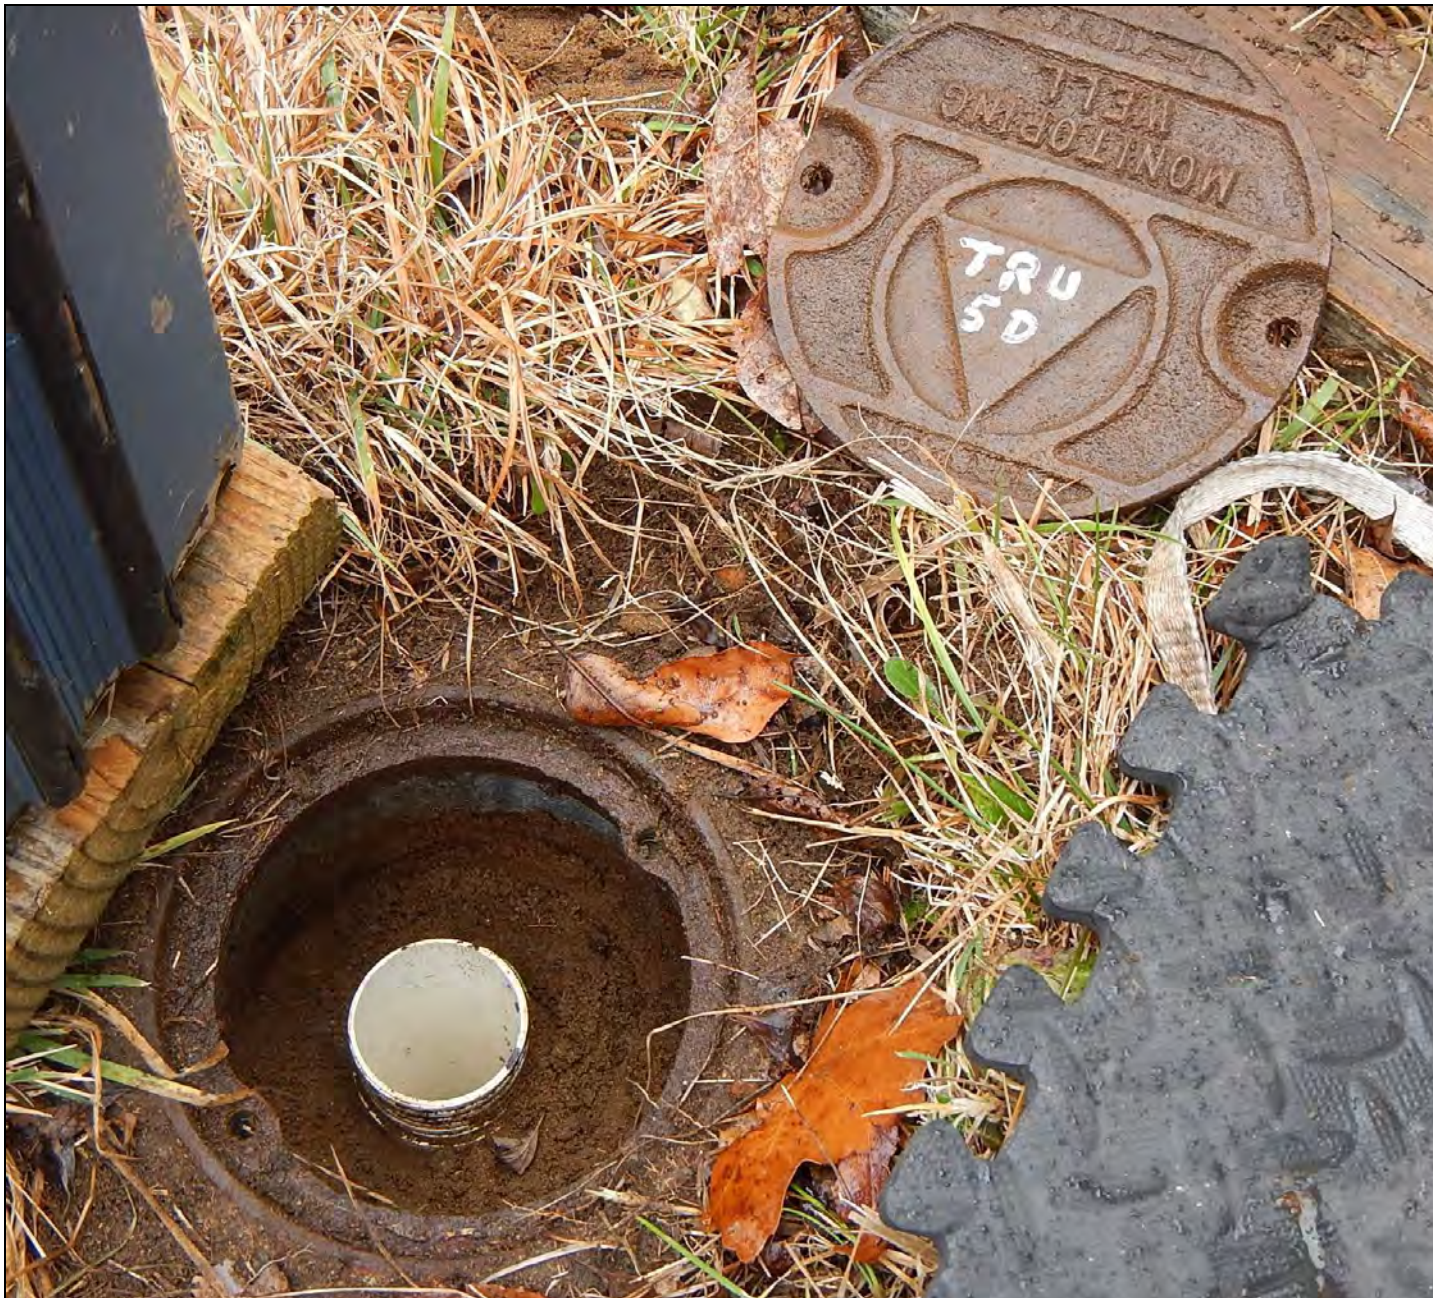
Figure C-32

Well TRU-5D is located about 2500 ft upstream of the dike at the edge of the wetlands south of the Pamet River. The ground surface elevation is about 6 ft above NAVD88 and the depth of the well is 60 ft. This well is co-located with TRU-5S.

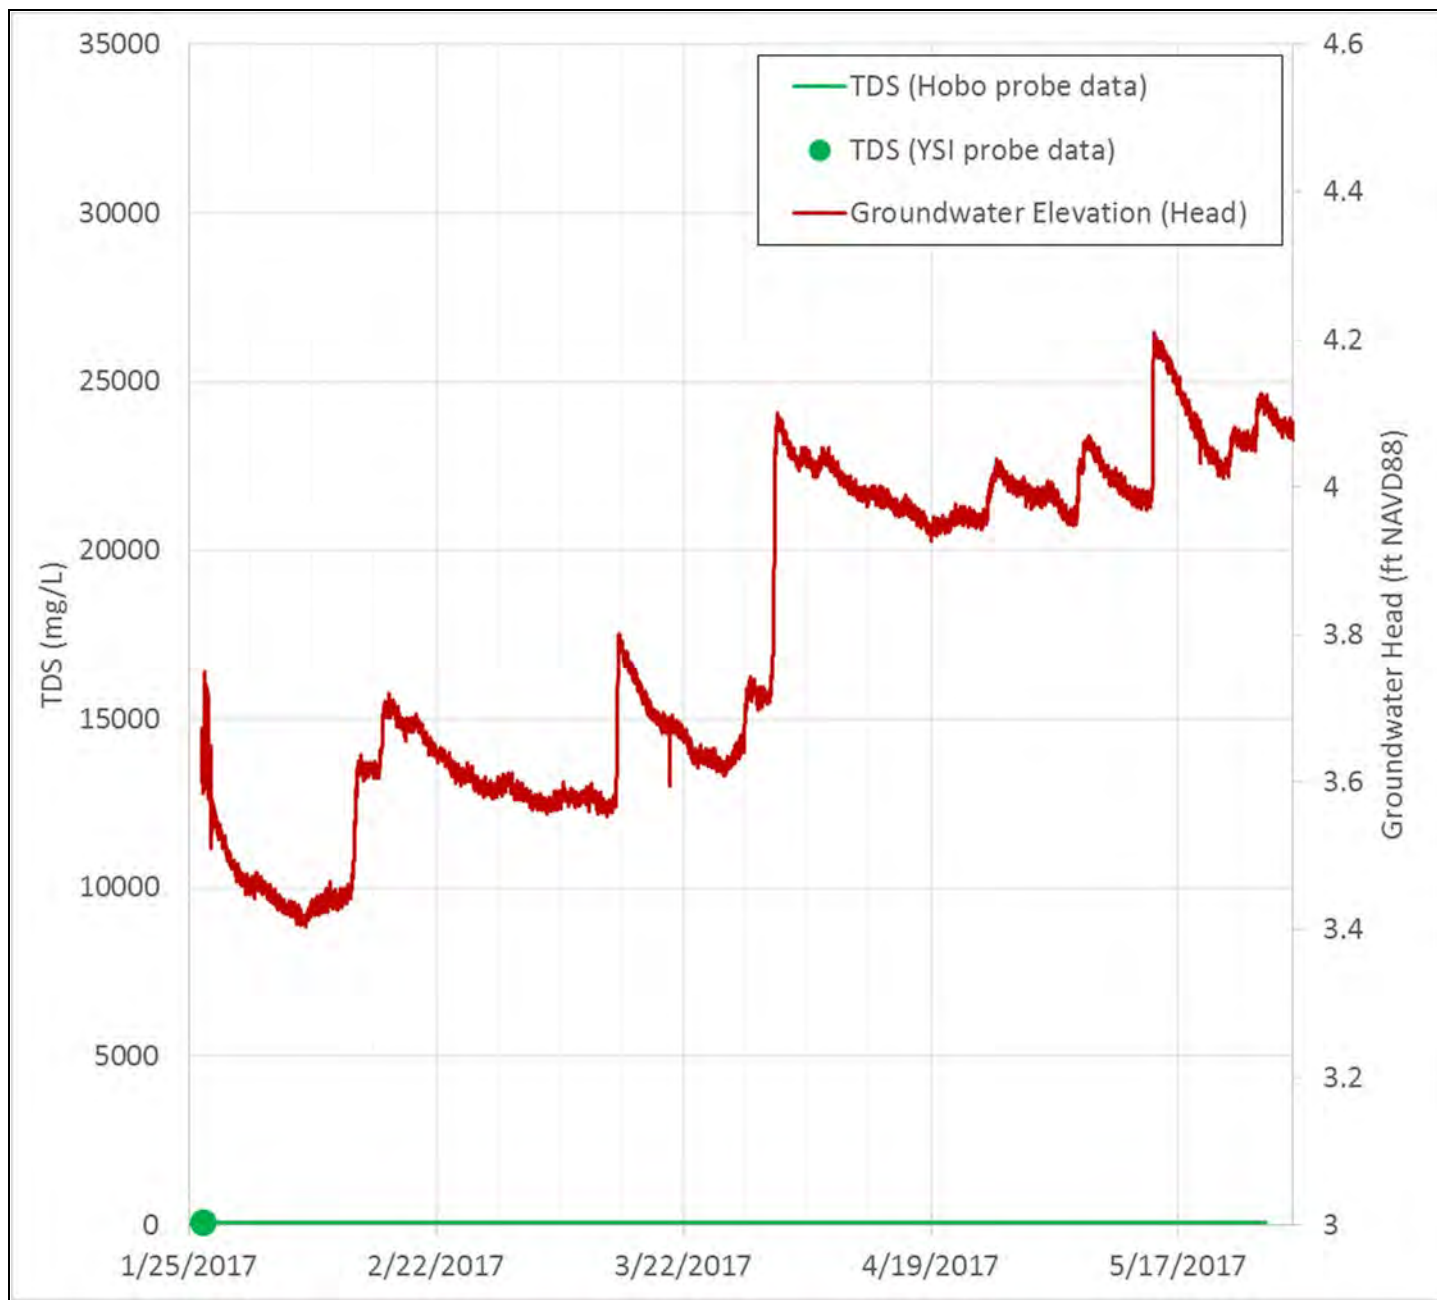
Figure C-34

The instantaneous TDS measurement at this well in January 2017 showed a TDS of 77 mg/L, indicating very fresh water. The continuous TDS data shows a very small variation of TDS, varying only between 75.52 mg/L and 78.95 mg/L over 4 months. The reason for the small variation is unknown but may indicate a problem with the probe.

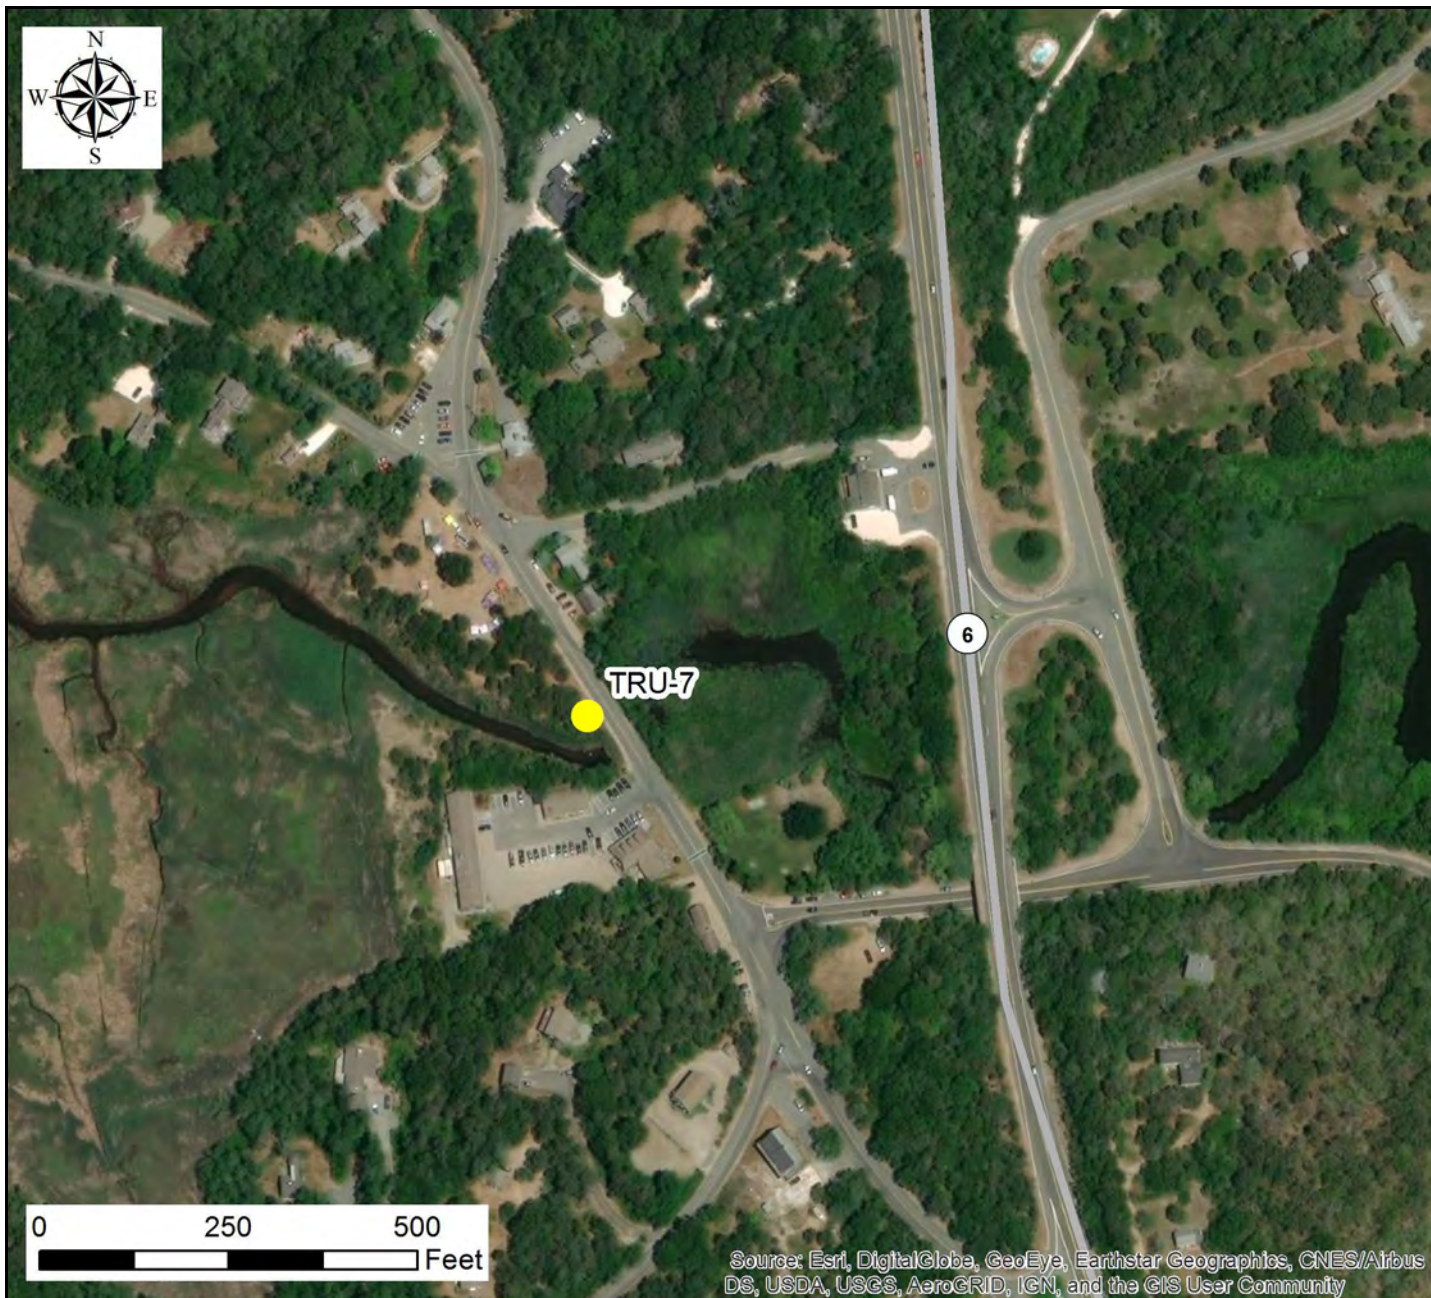
Figure C-41

TRU-7 is located just north of Wilder's Dike and is 15 feet deep. The ground surface elevation at this location is approximately 7 ft above NAVD88.

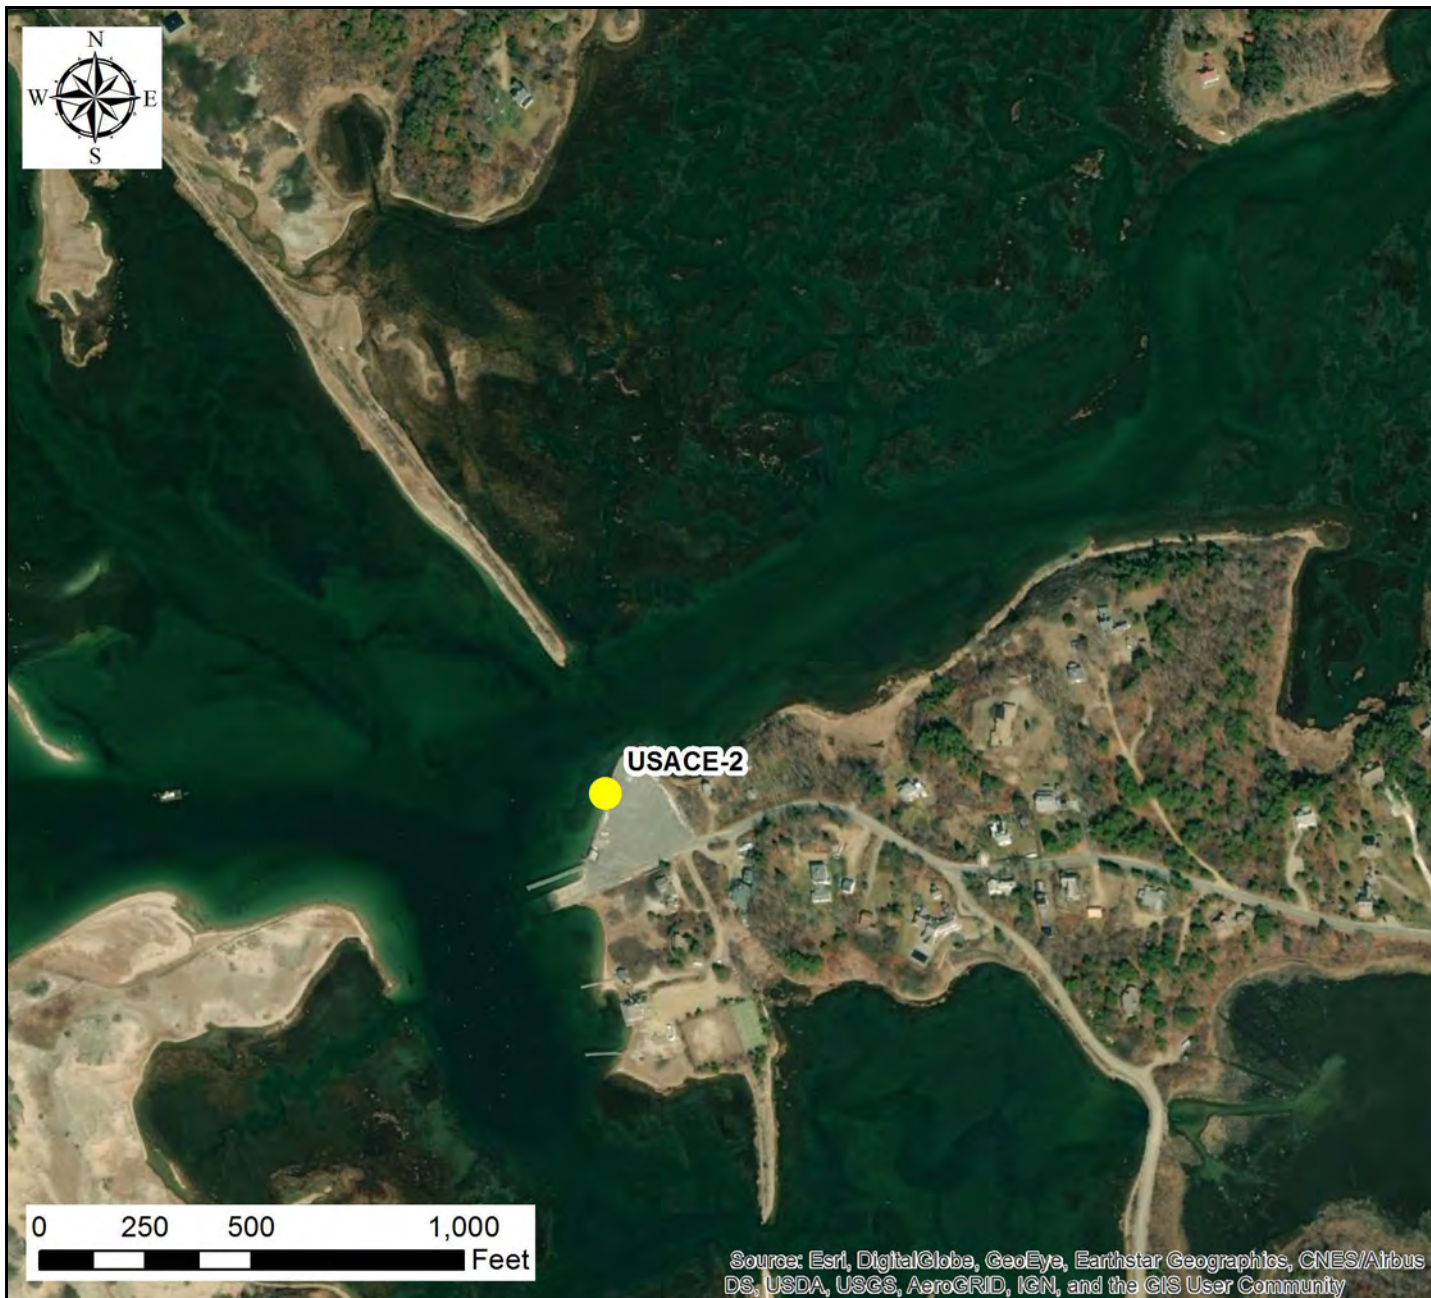
Figure C-46

USACE-2 was hand-driven into an area on the south side of Pamet River which was dry during low tide but inundated during high tide. To accommodate the large swings in surface water depth, this well had a large stick up and measured water levels only 9.5 feet below the ground surface.
