## SECTION 22 - PLANNING ASSISTANCE TO STATES PROGRAM

# Pamet River Investigation Truro, Massachusetts

November 2019

US Army Corps  
Of Engineers  
New England District

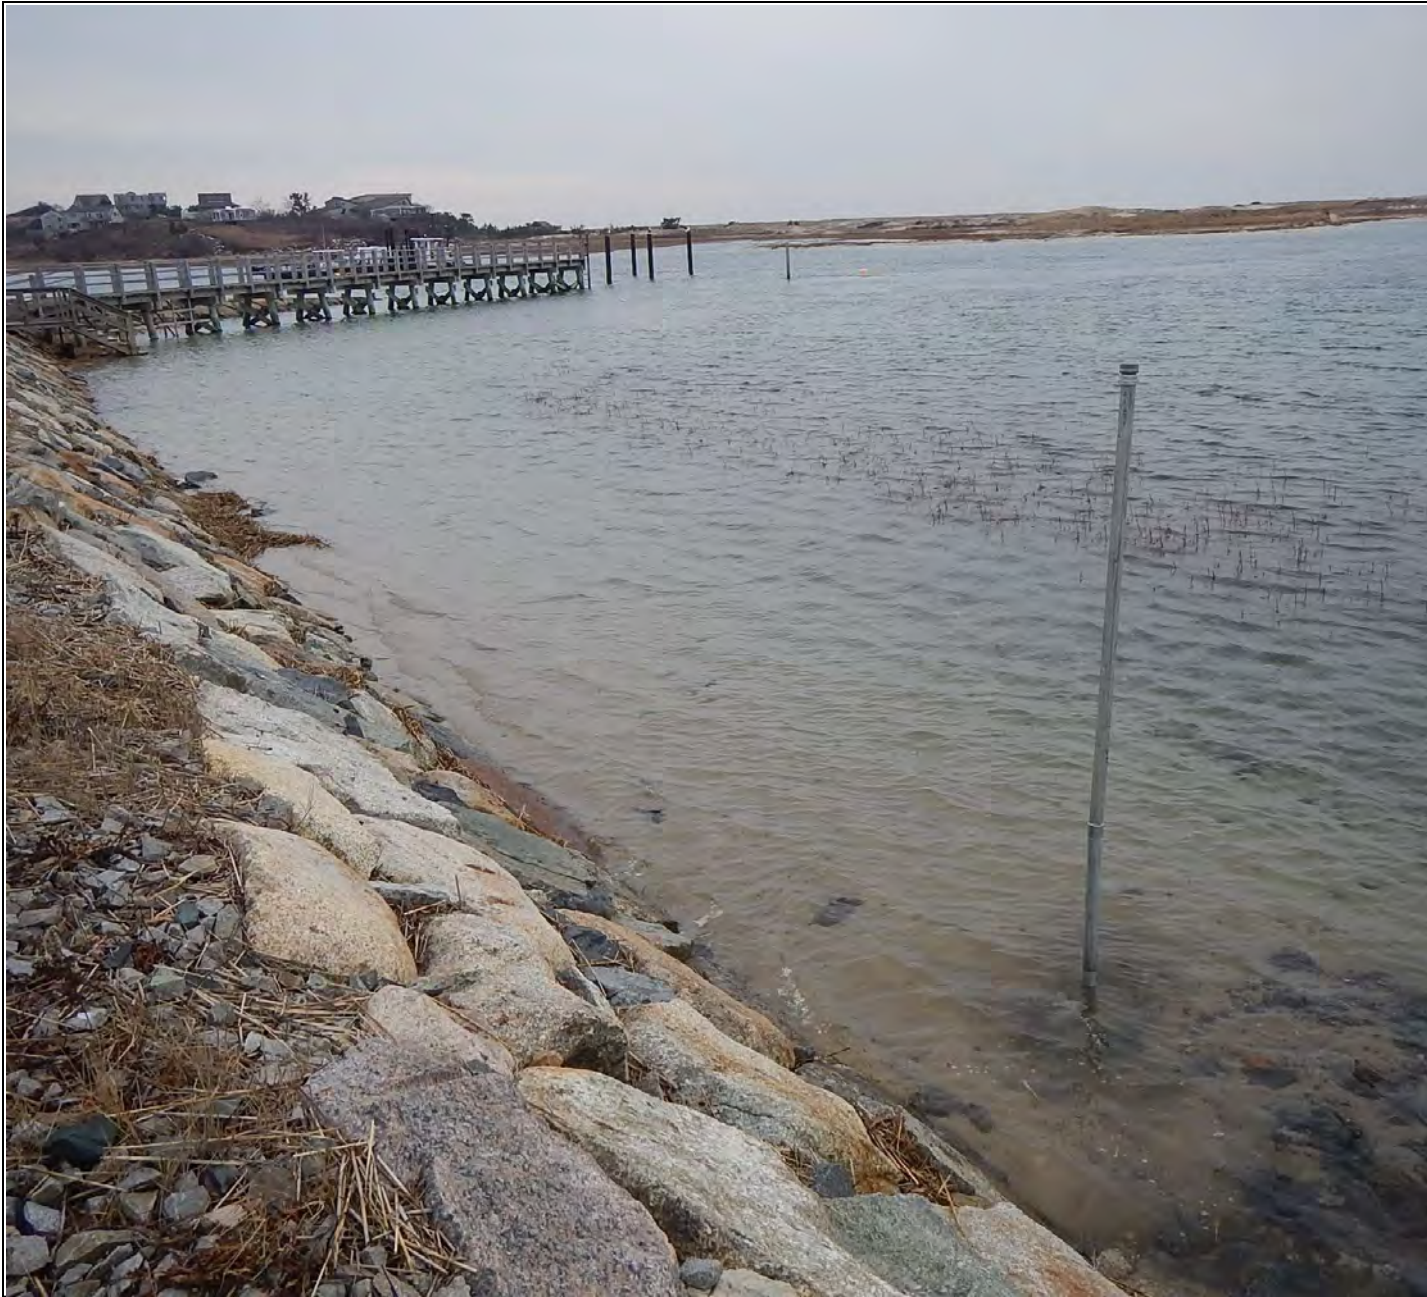
Figure C-47

USACE-2 was hand-driven into an area on the south side of Pamet River which was dry during low tide but inundated during high tide. To accommodate the large swings in surface water depth, this well had a large stick up and measured water levels only 9.5 feet below the ground surface.

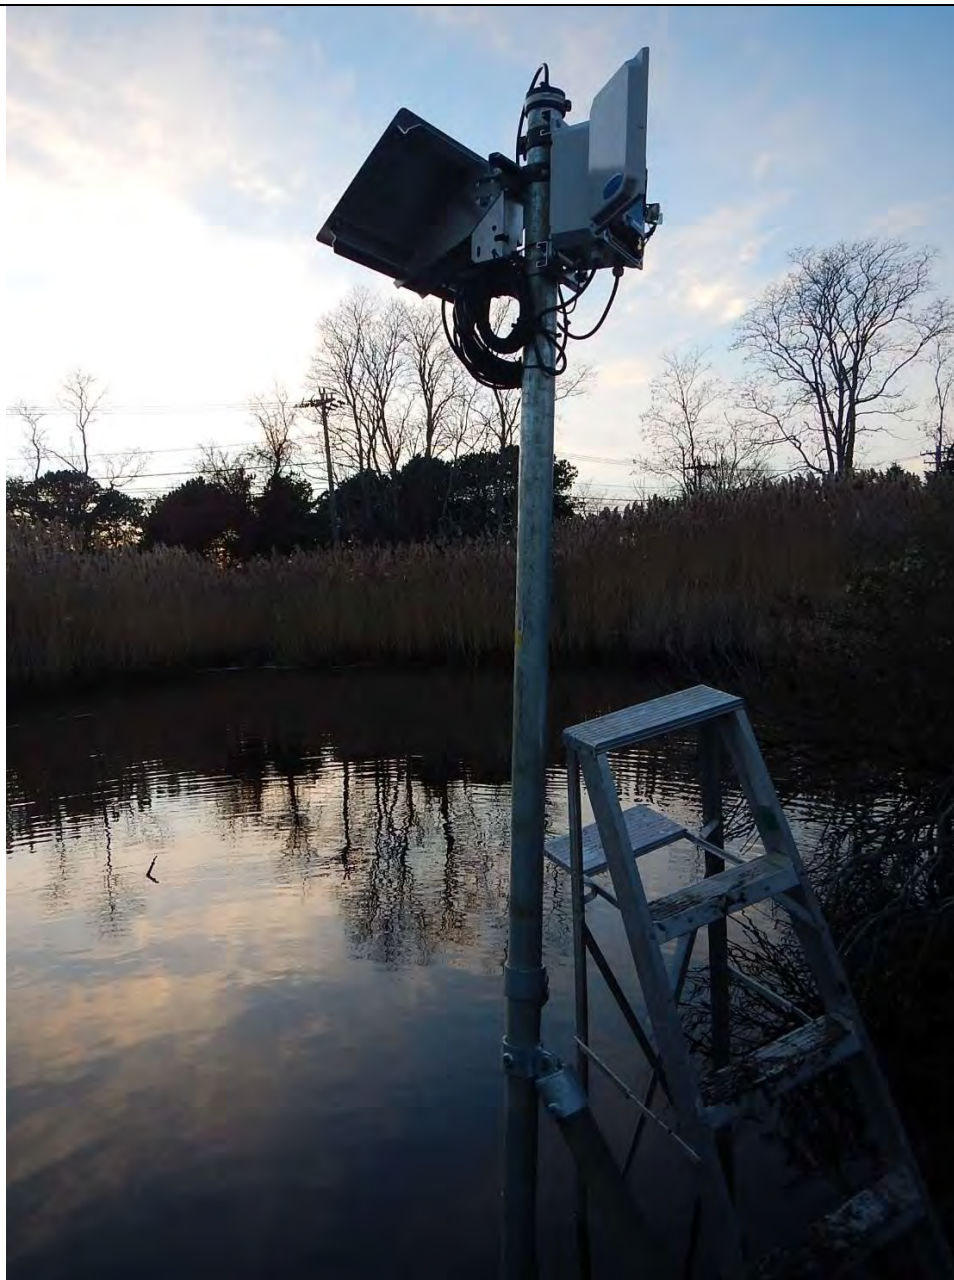
Figure C-53

Pamet 2 Tide Gage (Photo December 2016)

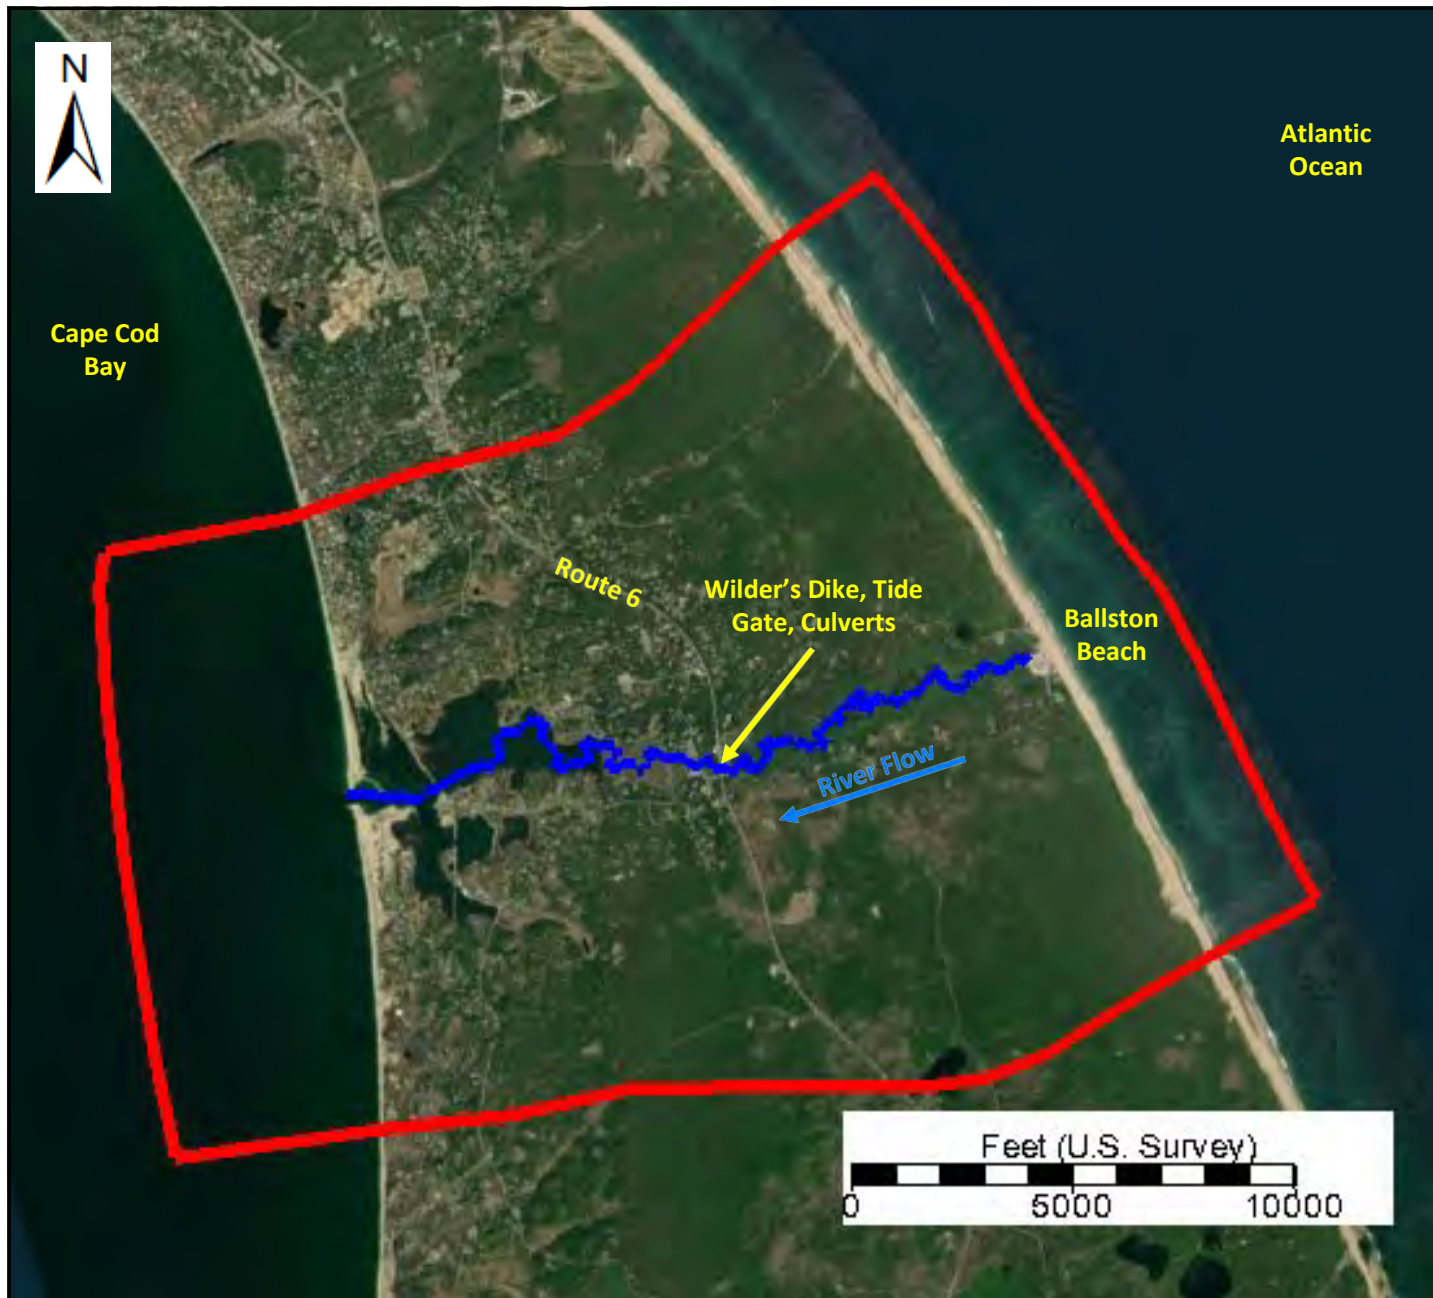
Figure shows boundaries of model (red boundary) and Pamet river (blue line).

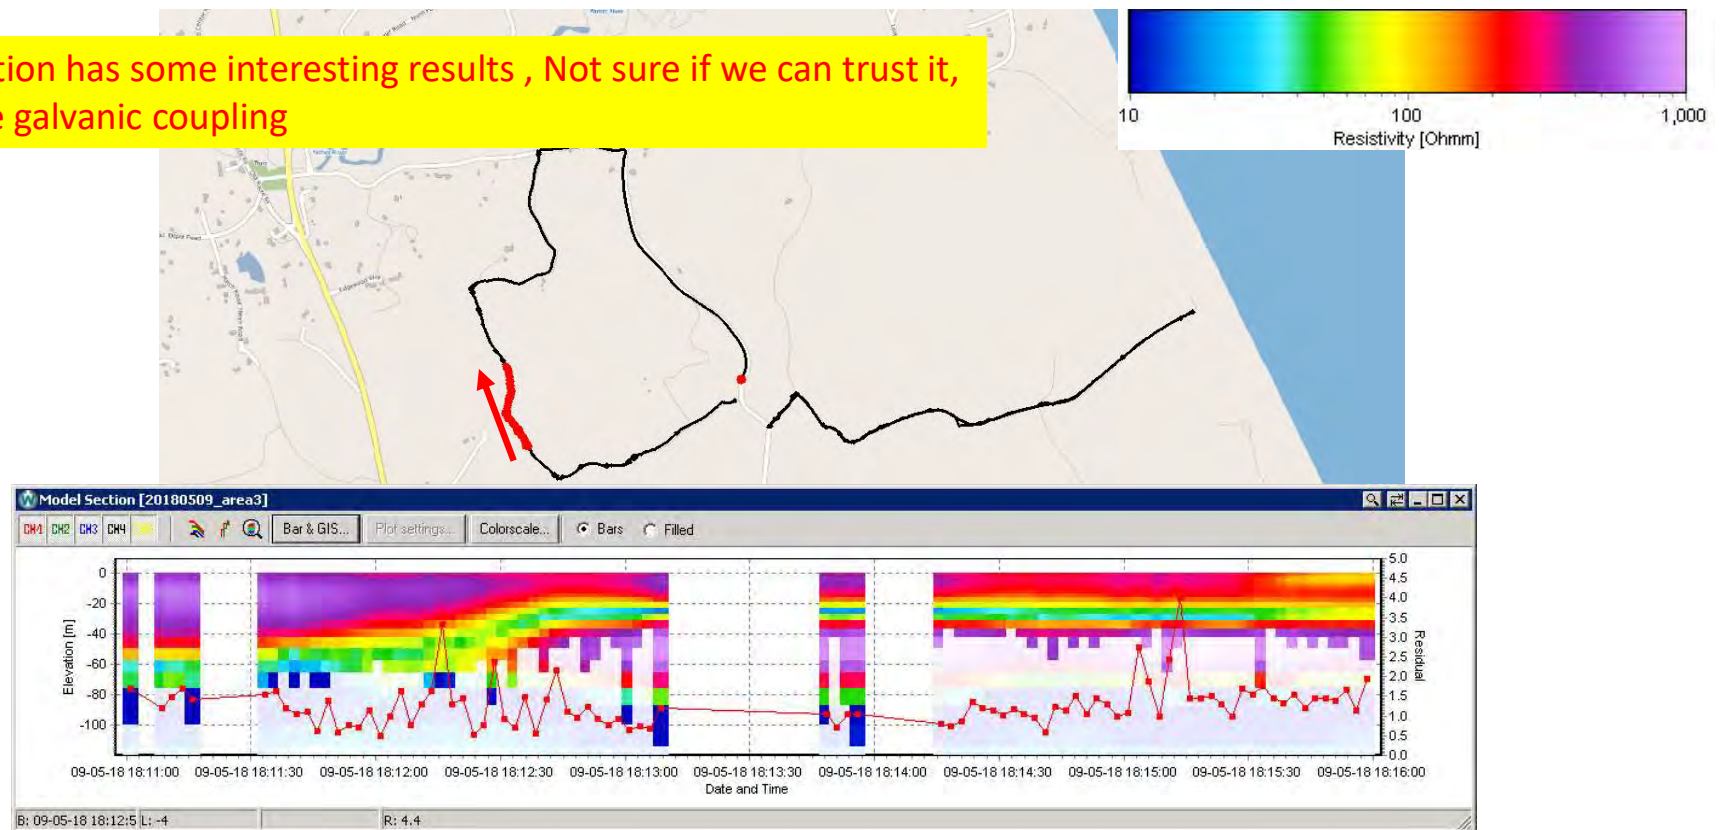
This section has some interesting results , Not sure if we can trust it, could be galvanic coupling
